RE: Construction Services for Idle Hour Park Improvements
LFUCG Bid No. 103-2015

PROJECT:	Idle Hour Park	JOB NUMBER:	LX160075
CLIENT:	Bluegrass Contracting	WEATHER:	Clear, Low 80's
CSI PROFESSIONAL:	Shawn Ferrell - NICET II, SI	DATE:	Tuesday, May 24, 2016

Material Testing - Summary of Observations

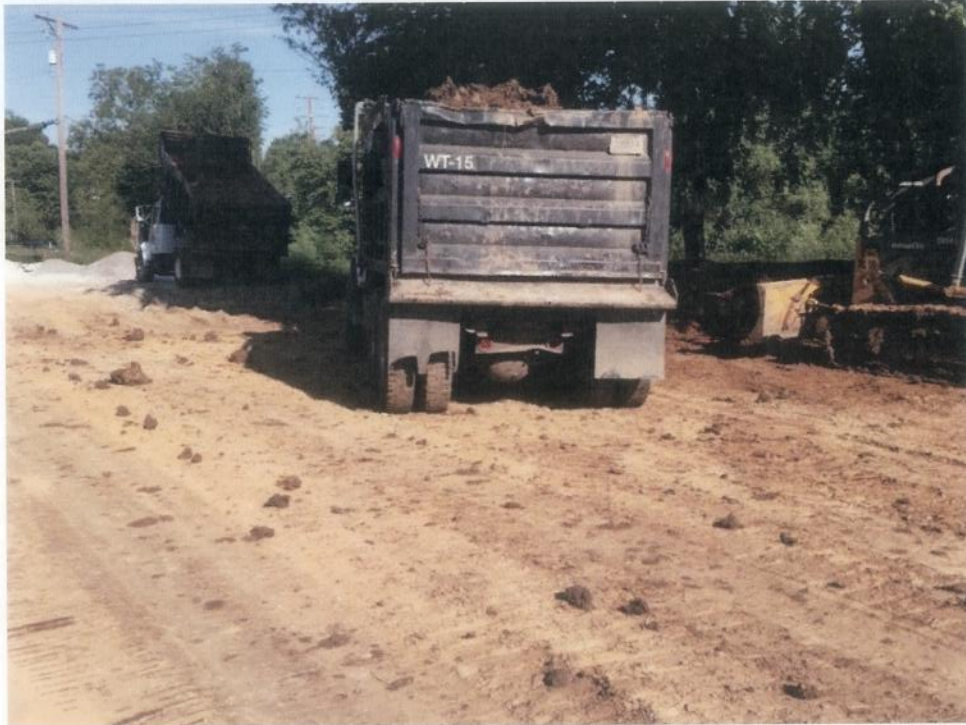
Photo 1: View Of Roadway Being Cut To Grade

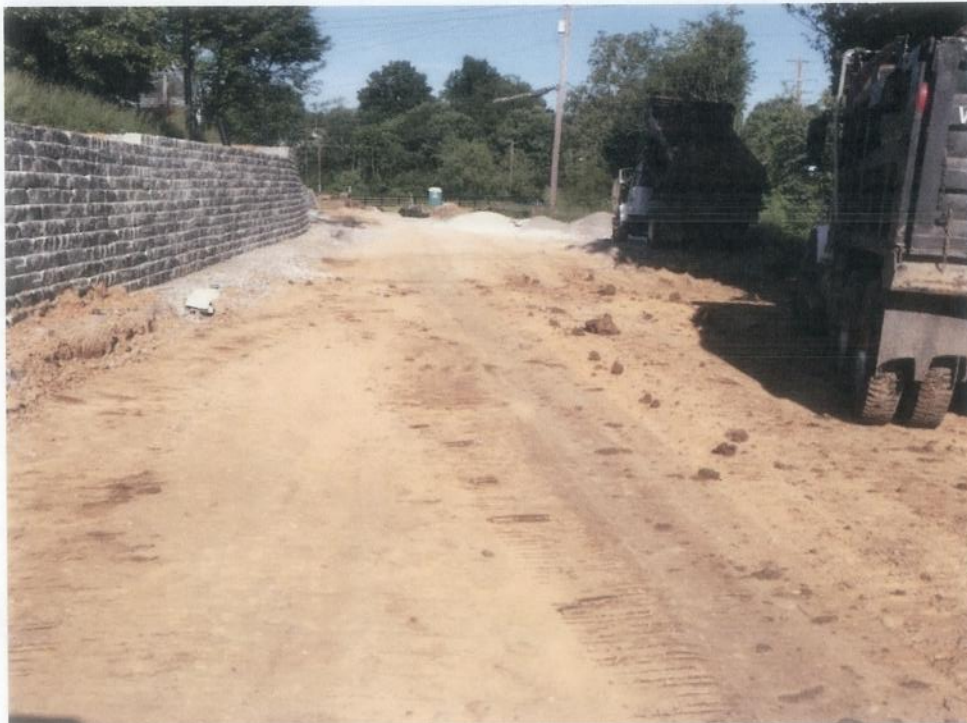
Photo 2: View Of Area Along The Retaining Wall

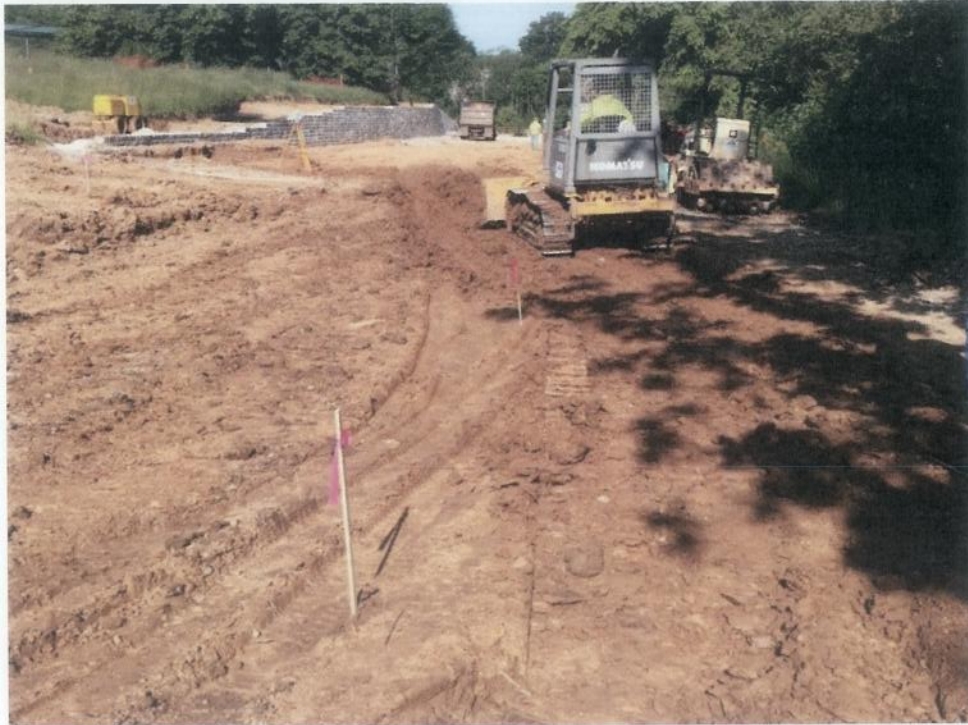
Photo 3: View Of Roadway Being Cut To Grade

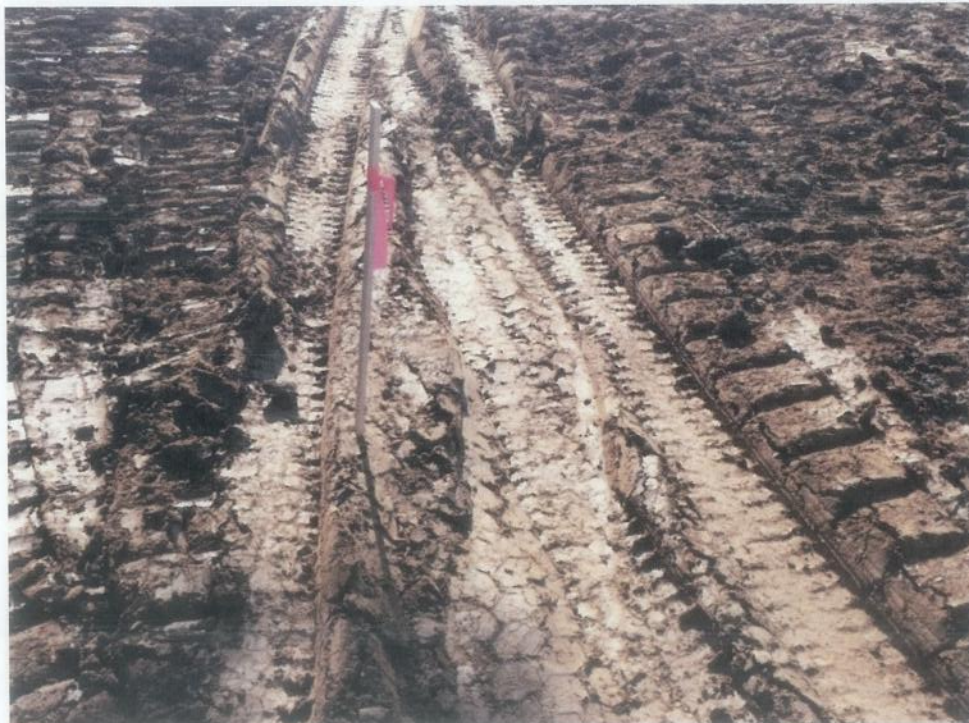
The proof roll revealed soft pumping material throughout the roadway. The pumping was evident throughout the full width of the proposed roadway. The soft pumping area measured to be 53 feet by 32 feet and 100 feet by 20 feet. We would recommend to extend the roadway undercut 5 feet beyond the roadway to maintain stability for a total of 363 cubic yards measured to be undercut and replaced.

Photo 4: View Of Loaded Truck Performing Proof Roll For The Subgrade

Based on our reconnaissance of the site and our understanding of the project we believe the soft soils encountered will not support the proposed construction and will need to be stabilized to facilitate the construction above the subgrade. Such stabilization can be achieved by undercutting the soft materials down two feet, lining the soft area with a reinforced geotextile fabric and backfilling with a #2 stone like aggregate back up to the designed subgrade elevation. Once the stabilization has occurred the area should be evaluated by proof rolling to verify stability prior to placement of the pavement section.

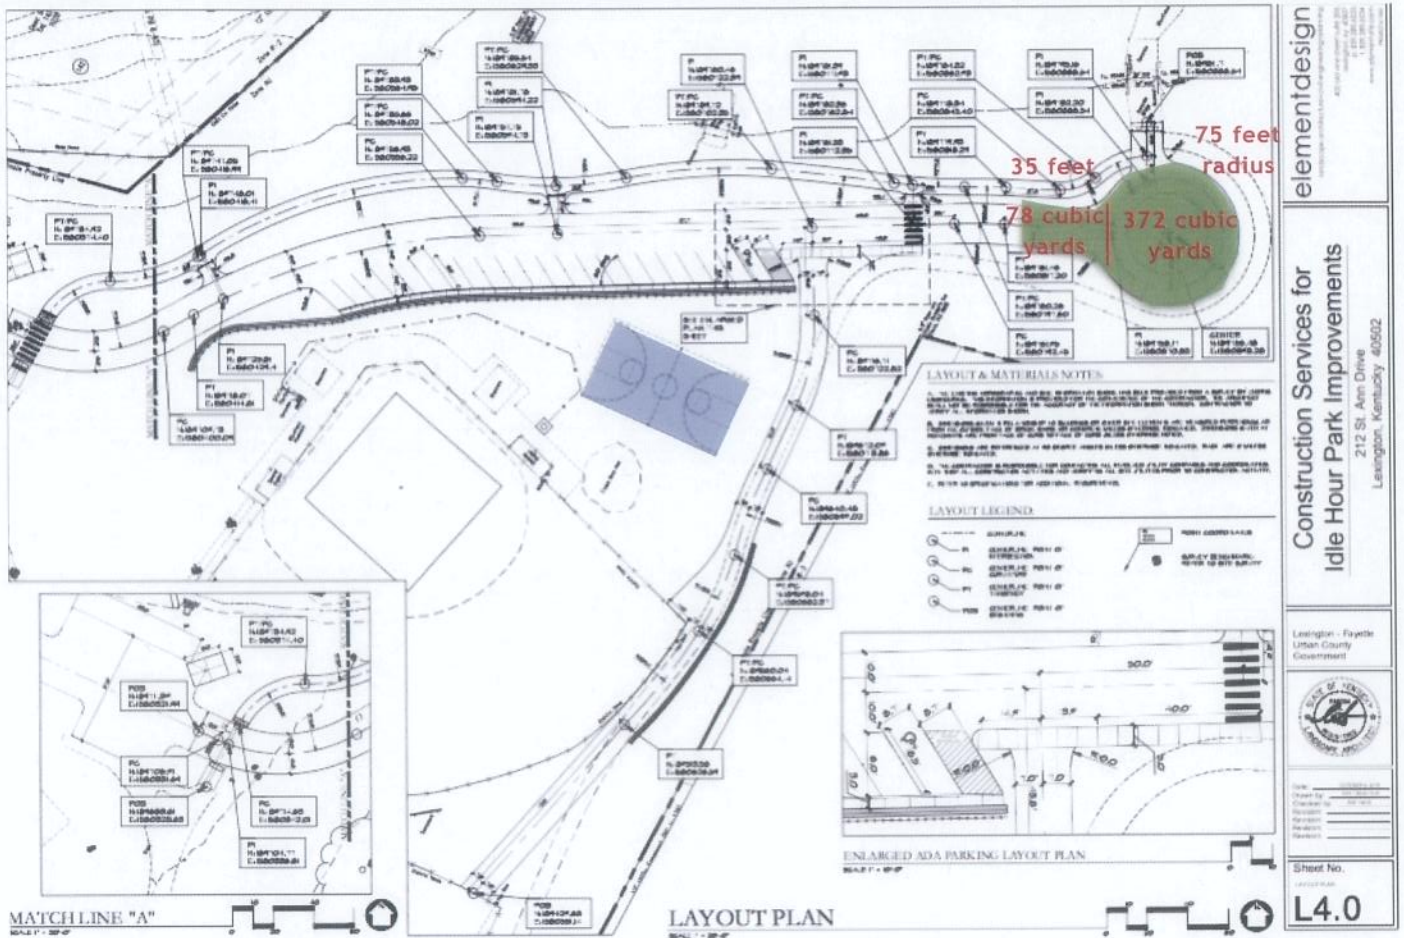
Figure 1: Approximate Area of Observations

CSI observed a proof roll conducted by the contractor for the soil sub-grade approximately 35 feet of the roadway and the cul-de-sac utilizing a loaded tri-axle dump truck. The proof-roll consisted of the loaded truck routing over the sub-grade in a forward and backward motion, then moving laterally one tire width and repeating the motion until the exposed sub-grade had been rolled. The proof roll revealed soft pumping material throughout the roadway and the cul-de-sac. The pumping was evident throughout the full width of the proposed roadway. The soft pumping area measured to be 35 feet by 20 feet for the roadway and 75 feet radius of the cul-de-sac. We would recommend to extend the roadway undercut 5 feet beyond the roadway to maintain stability for a total of 450 cubic yards measured to be undercut and replaced.

Based on our reconnaissance of the site and our understanding of the project we believe the soft soils encountered will not support the proposed construction and will need to be stabilized to facilitate the construction above the subgrade. Such stabilization can be achieved by undercutting the soft materials down two feet, lining the soft area with a reinforced geotextile fabric and backfilling with a #2 stone like aggregate back up to the designed subgrade elevation. Once the stabilization has occurred the area should be evaluated by proof rolling to verify stability prior to placement of the pavement section.

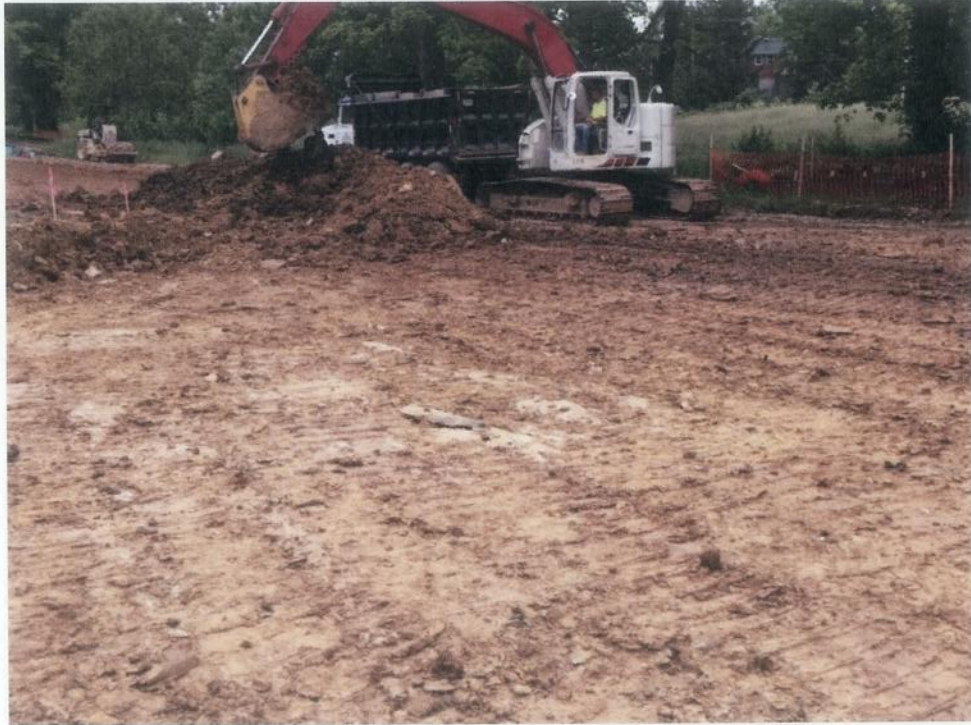
Photo 1: View Of Roadway Being Cut To Grade

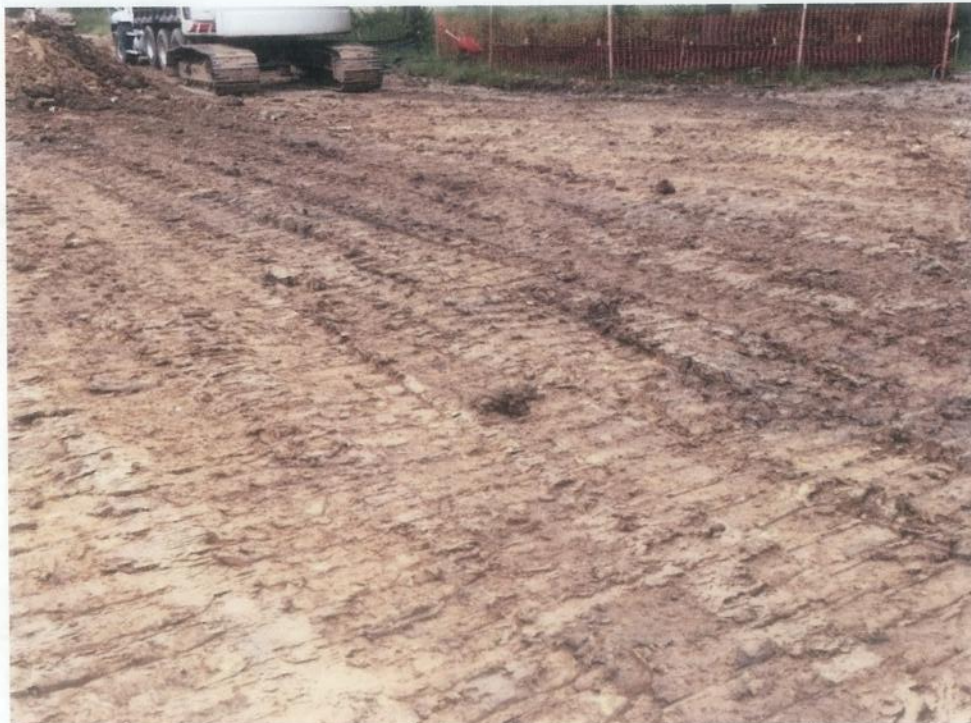
Photo 2: View Of Cul-De-Sac Area Being Cut To Grade

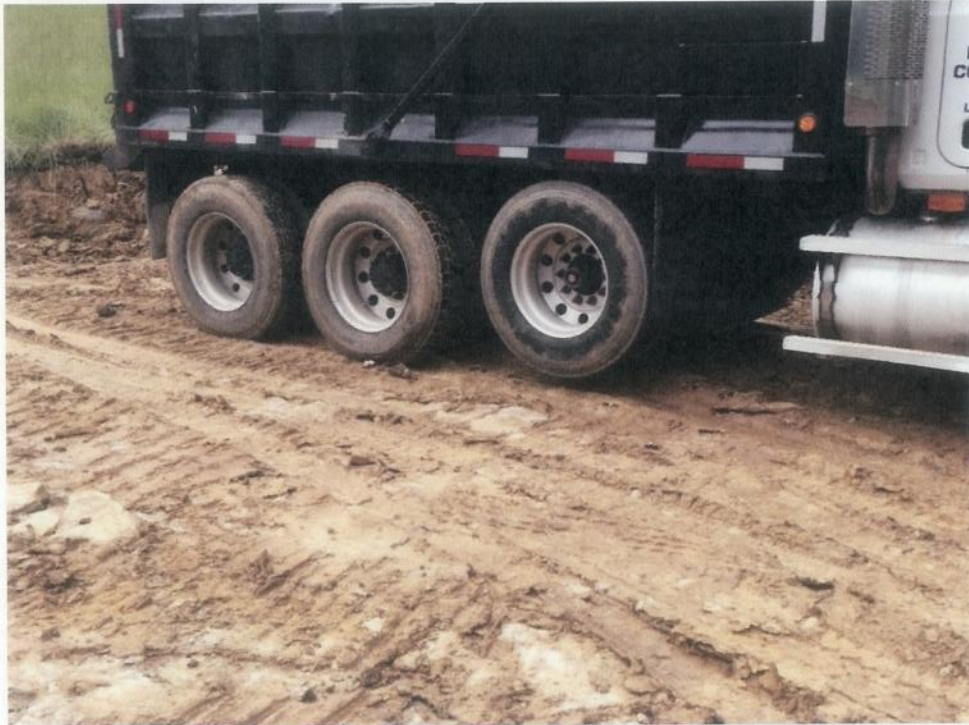
Photo 3: View Of Loaded Truck Performing A Proof Roll To The Sub-Grade

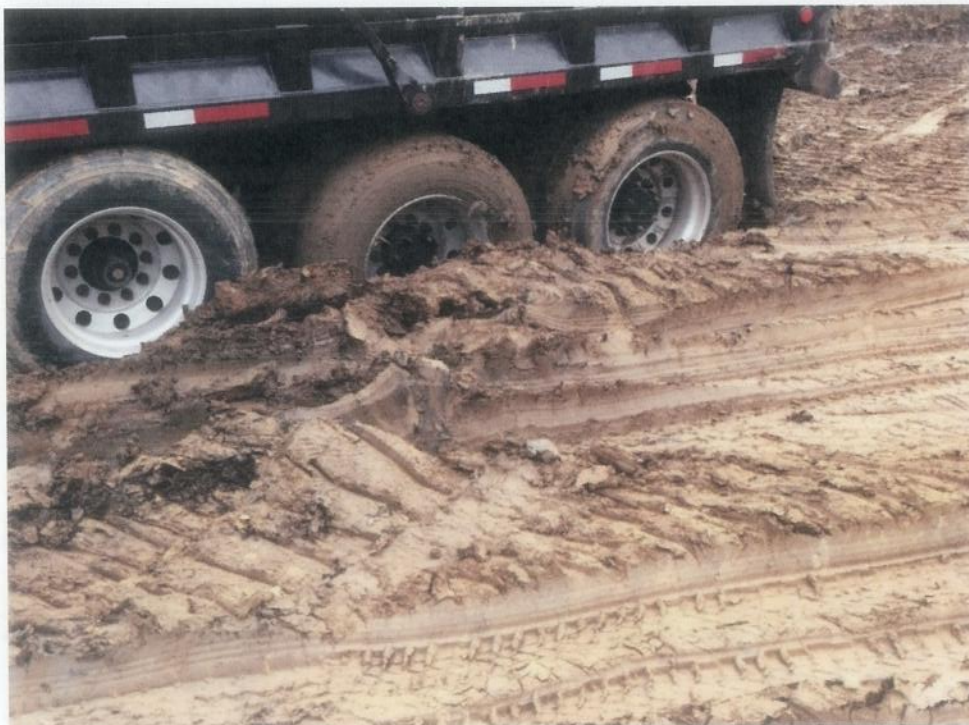
Photo 4: View Of Truck Rutting During The Proof Roll

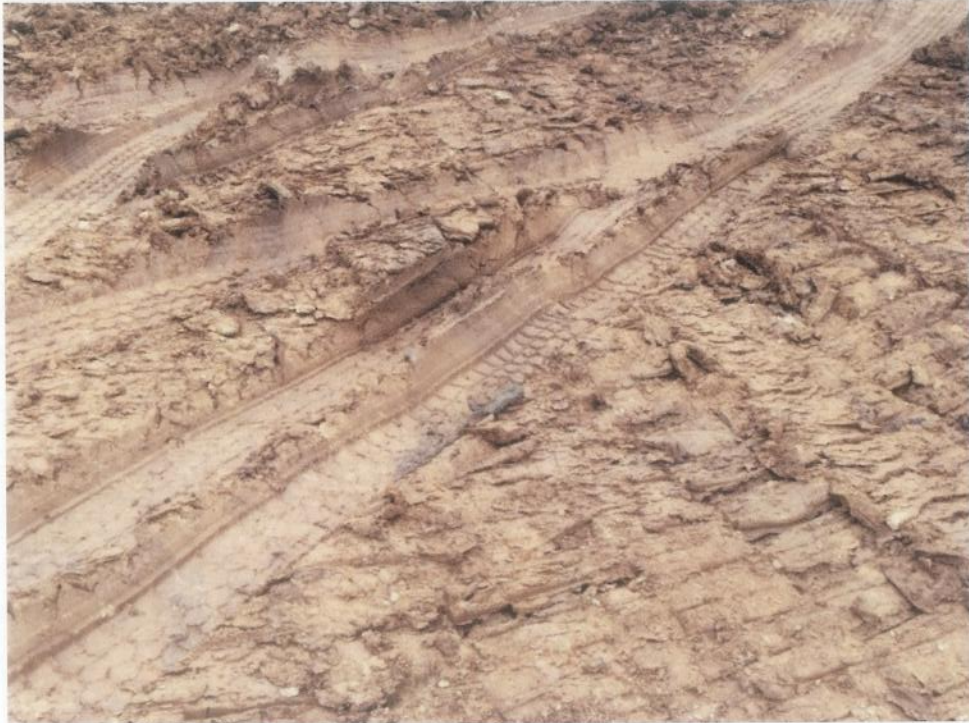
Photo 5: View Of Ruts In The Cul-De-Sac Area

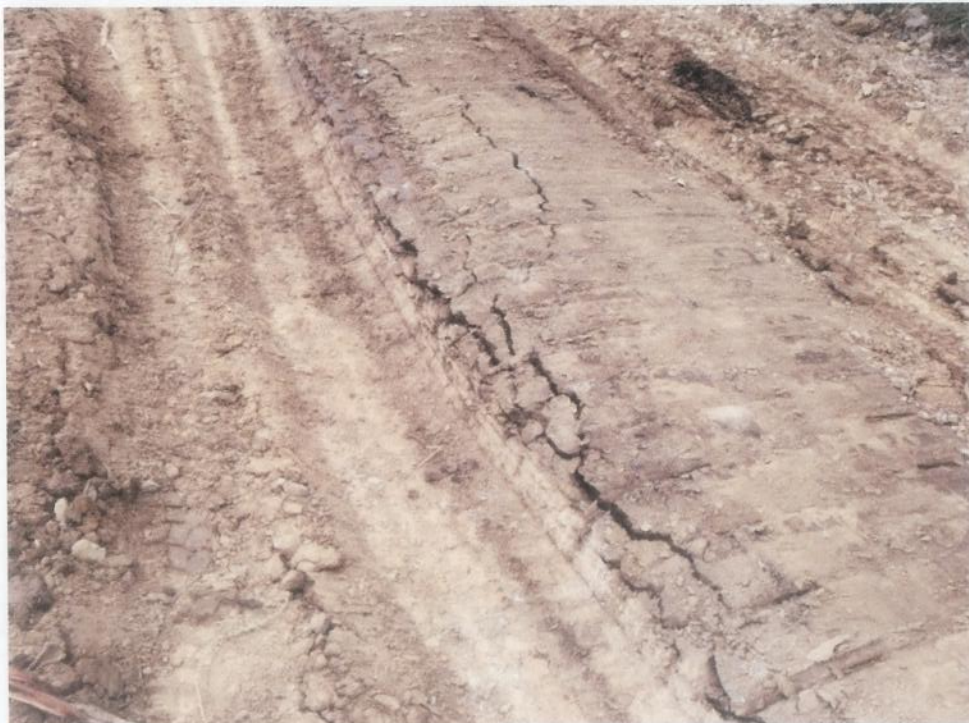
Photo 6: View Of Ruts On Section Of Roadway

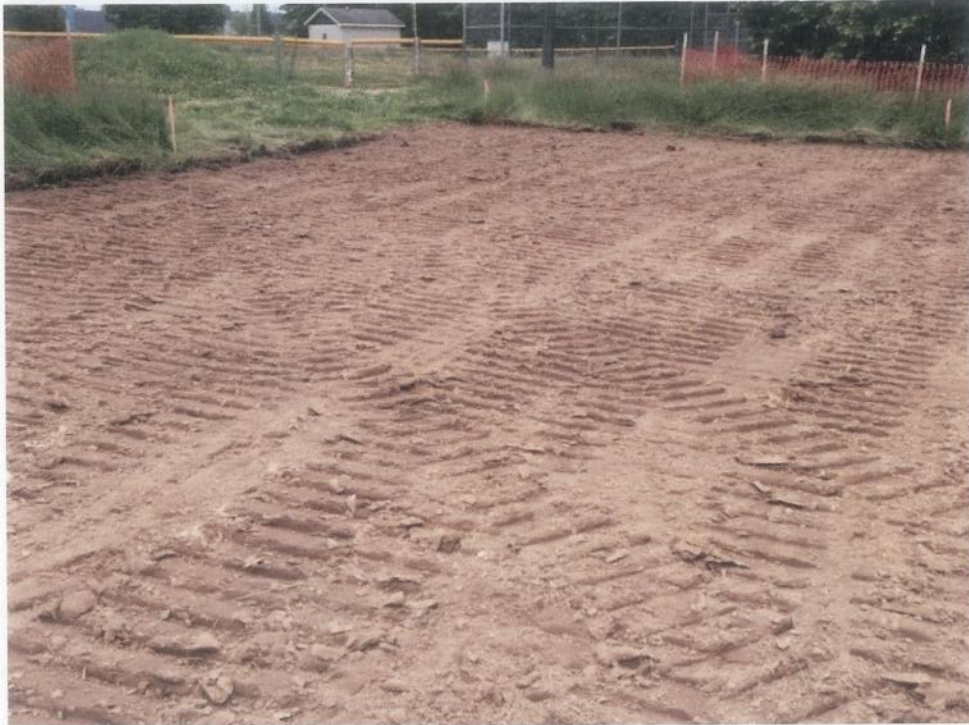
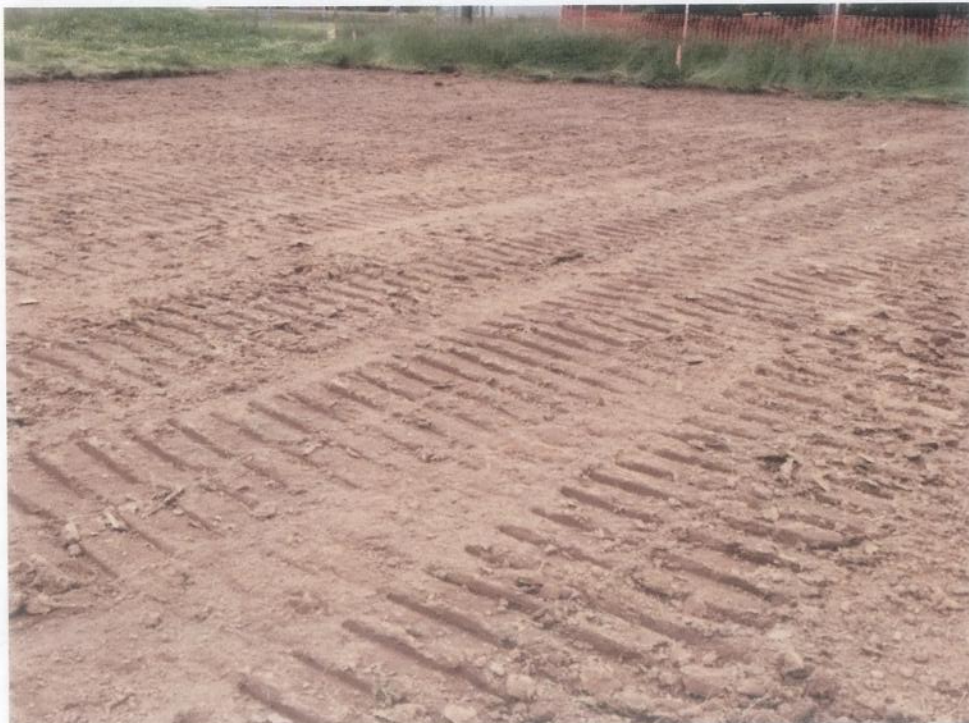
Bluegrass Contracting cut the proposed basketball court to sub grade elevation. After the area had been cut, it was observed and appeared to have mixture of some clay and topsoil at this elevation.

Photo 7: View Of Basketball Court Cut To Grade With Mixture Of Top Soil And Clay

Photo 8: View Of Basketball Court Cut To Grade With Mixture Of Top Soil And Clay
