Date 06/27/2024  
To LFUCG Historic Preservation  
Cc Specs  
From Gatton Park  
Subject Proposed Renovation of Stone Walls  
at Gatton Park

The purpose of this memo is to summarize the issues surrounding the historic stone walls at Gatton Park and the proposed remediation to make the area safe prior to park opening in summer 2025. This summary has been prepared by Sasaki in coordination with Strand SAI for Gatton Park and it is intended to facilitate communication with LFUCG Historic Preservation.

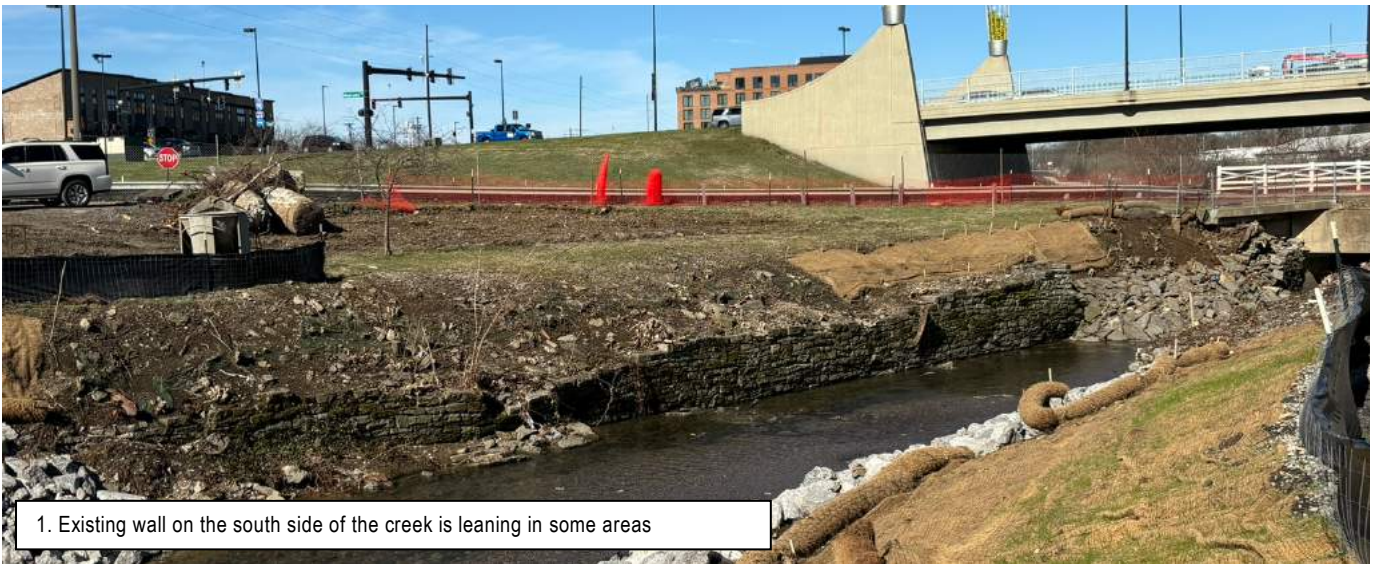
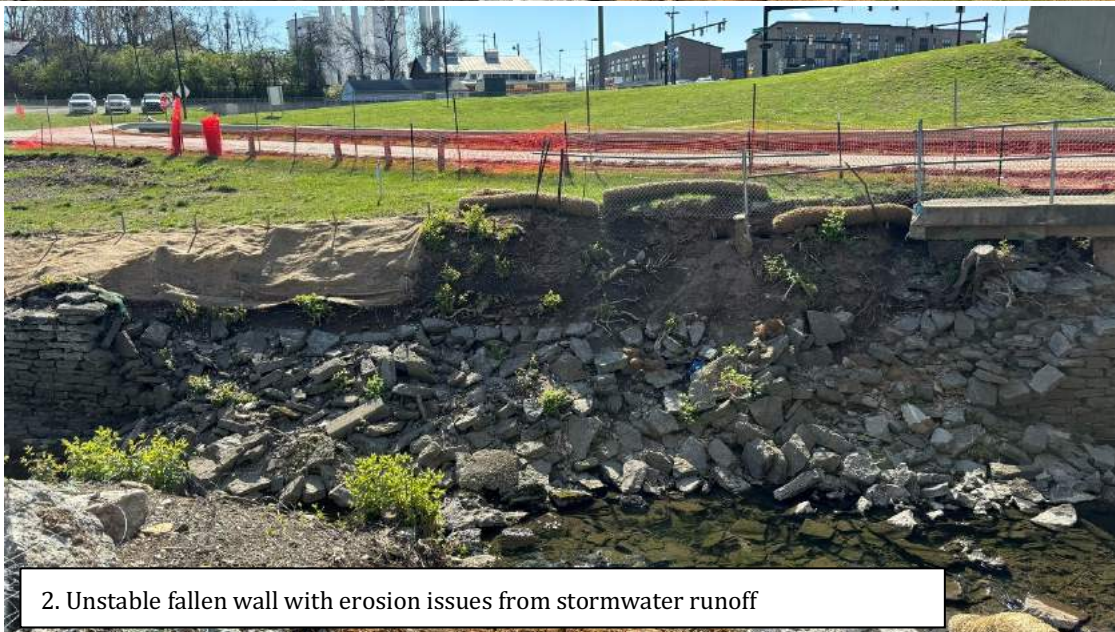
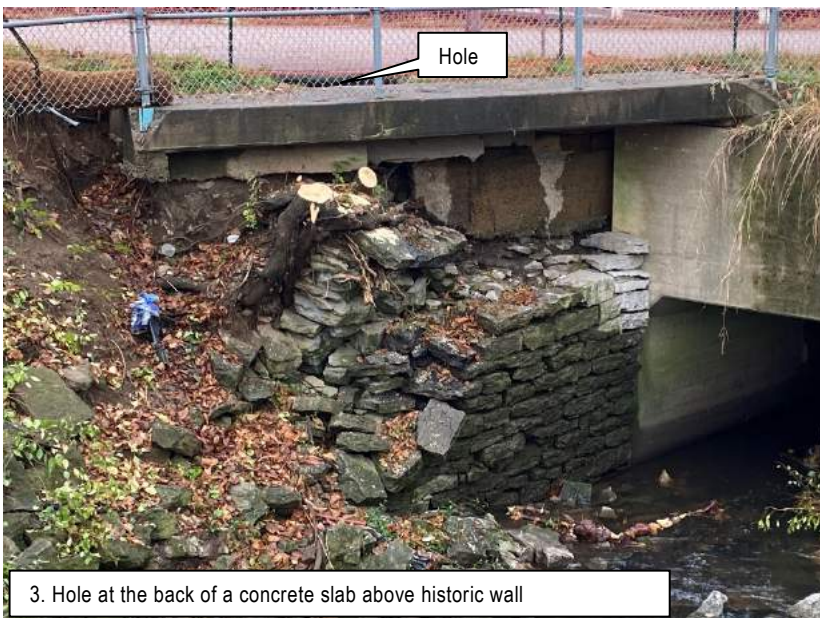
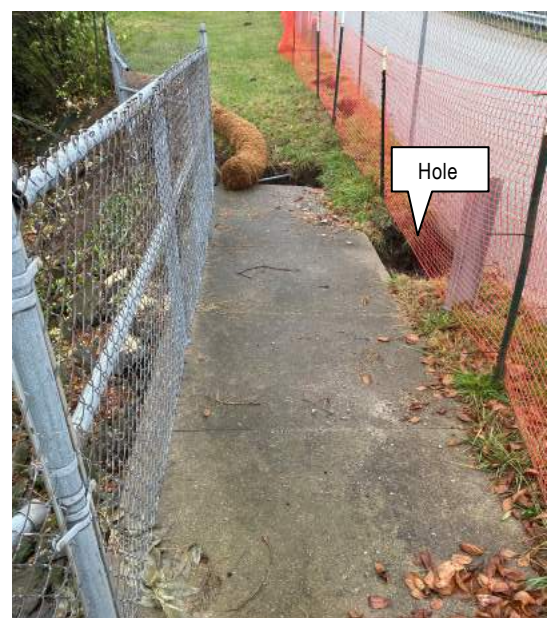
Photos of the current condition are included on p. 3.

Gatton Park on the Town Branch is currently under construction with an anticipated opening in late summer 2025. The park encompasses a portion of Town Branch creek, including areas of historic walls leading to a culvert that runs under Cox St. and Oliver Lewis Way. On the north side of the creek there are approximately 55' of wall still standing and on the south side there are approximately 95' of wall still standing. Significant portions of the wall have fallen. The existing walls are believed to be dry stacked construction and are leaning toward the creek in many places.

The full extent and condition of the walls became apparent after construction began and vegetation was cleared from the banks of the creek. The condition poses concerns for Gatton Park for several reasons, outlined below.

- The dry stacked walls that are still standing are leaning in some areas and may fall at any time.
- The portions of fallen wall are not stable and are susceptible to continued erosion from both the creek and stormwater runoff.
- On the south side of the culvert, erosion has led to a hole at the back of a concrete slab. This condition is not feasible to fix without impacting the historic wall and fallen wall below.

Gatton Park discussed these points both internally and with landscape architects, civil engineers, structural engineers, historic wall specialist, and employees of LFUCG. Ultimately, Gatton Park determined that the solution that creates the most stable and desirable condition for the park is to salvage the historic stone, build structural retaining wall where needed along the creek, and use the historic stone to face the new structural wall.

The proposed solution uses a retaining wall with stone wall in front only where it is necessary due to grading adjacent to the culvert. Further away from the culvert, where there is enough space to lay back the slope this option uses channel lining stones to create a vegetated boulder revetment and embankment plantings to stabilize the banks of the creek (the same method used along the part of the creek that has already been permitted and constructed).
