# LFUCG

# Cardinal Run Park North

# Vandalism Report

May 28, 2026

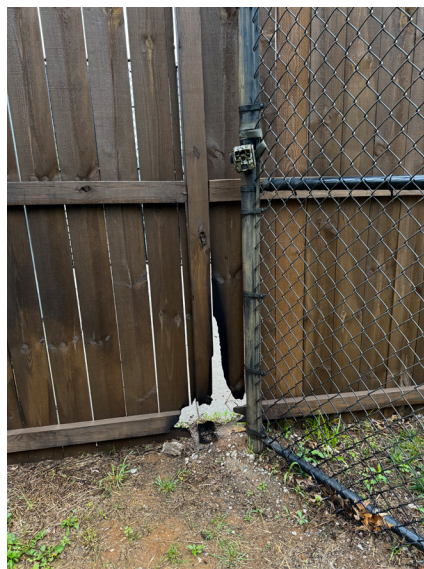
Damage to the wood dumpster enclosure is present. Replacement of the damaged components is recommended.

| Building | Location/Item | Repair Recommendation | Qty | Unit | Unit Cost | Line Total | Notes |
|---|---|---|---|---|---|---|---|
| Maintenance Building | Dumpster enclosure | Replace damaged wood enclosure components and associated hardware/posts as needed | 1 | LS | \$750.00 | \$750.00 | |

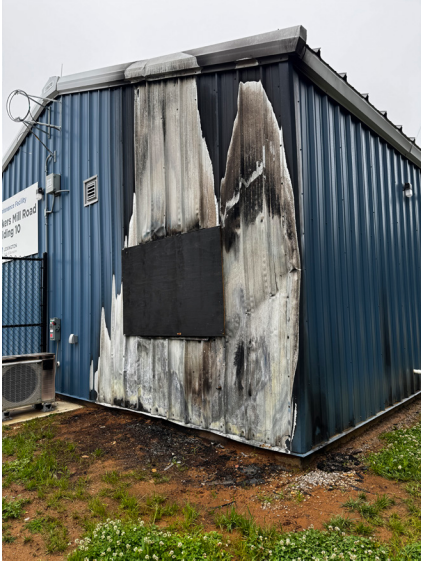
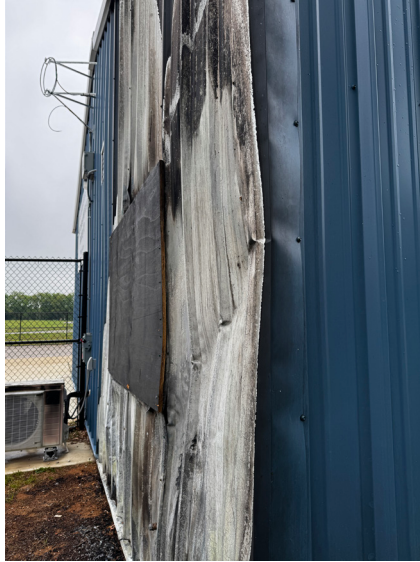
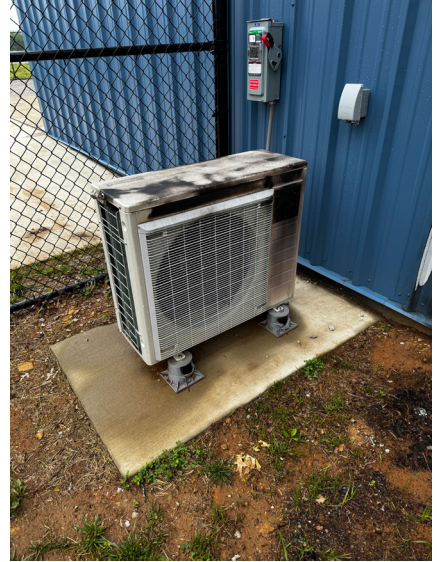
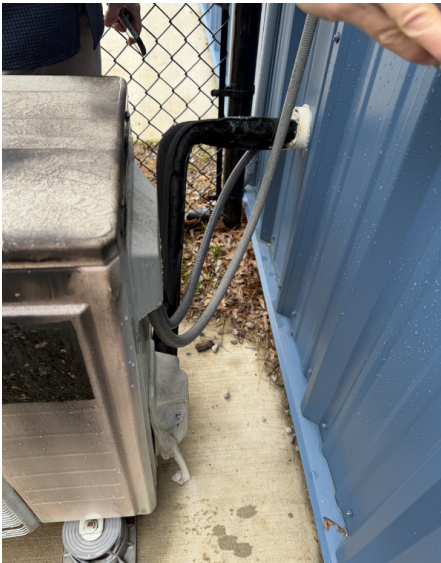
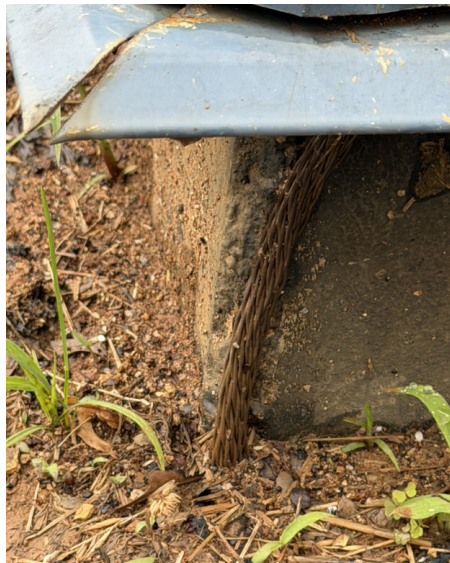
The southwest building façade is badly damaged. The following items are recommended to be addressed.

1. The pre-finished metal panels and trim are recommended to be replaced. Once the panels have been removed, further review is to occur as the internal metal stud framing / pre-engineered metal building framing may require remediation.
2. All fire and smoke damaged insulation is recommended to be replaced.
3. The Office window is recommended to be replaced.
4. The lightning protection grounding cable is recommended to be replaced.
5. All instances are recommended to be cleaned.
6. Seed and straw is recommended to be provided once all exterior remedial work is complete.
7. Replacement of the heat pump, refrigerant line set, electrical disconnect and wiring is recommended.
8. Replacement of the exterior GFCI receptacle and pulling of new conductors back to the panel is recommended.

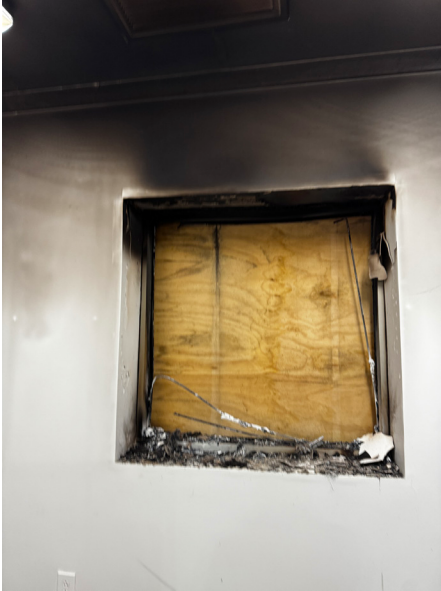
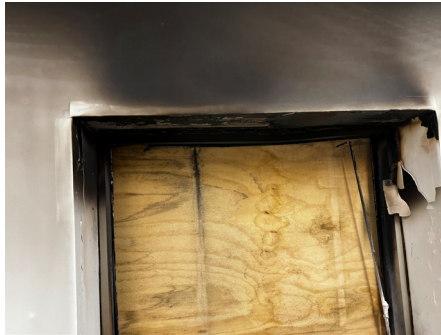
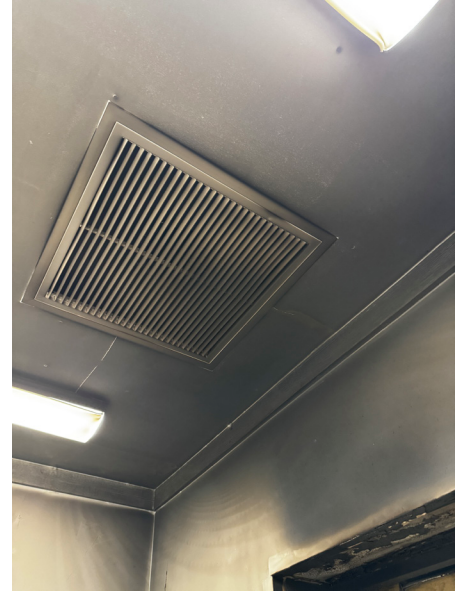
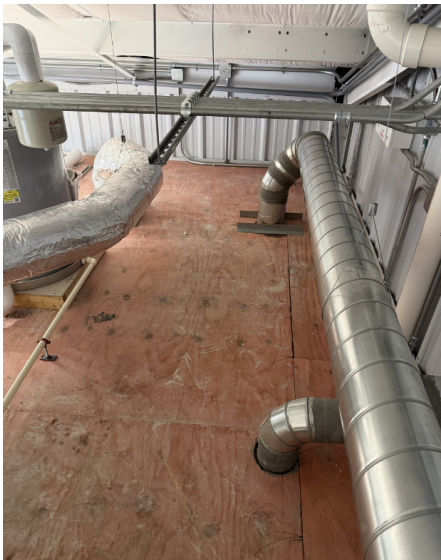
The Office has significant heat and smoke damage. The following items are recommended to be addressed.

1. The Office window is recommended to be replaced.
2. All drywall (walls and ceilings) are recommended to be replaced and repainted.
3. Once drywall has been removed, further review is to occur as the internal metal stud framing and building infrastructure may require remediation.
4. All fire and smoke damaged insulation is recommended to be replaced.
5. All instances are recommended to be cleaned.
6. All ductwork and the HVAC cooling coil is recommended to be cleaned.

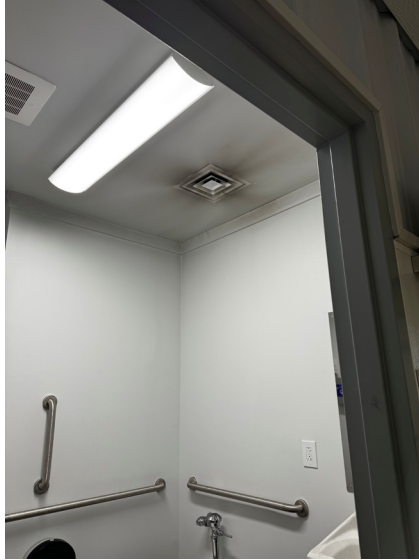
The Restroom has minor smoke damage. The following items are recommended to be addressed.

1. All instances are recommended to be cleaned and repainted.
2. Replacement of the HVAC supply diffuser and exhaust fan is recommended.
3. Replacement of all light fixtures is recommended.
4. Replacement of all receptacles and conductors is recommended.

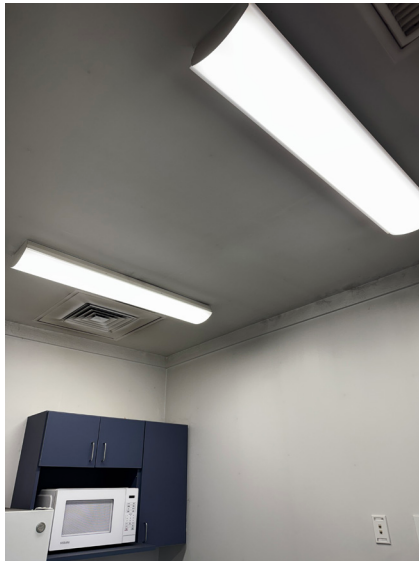
The Breakroom has minor smoke damage. The following items are recommended to be addressed.

1. All instances are recommended to be cleaned and repainted.
2. Replacement of all light fixtures is recommended.
3. Replacement of the HVAC supply diffuser and return grille is recommended.
4. Replacement of all receptacles and conductors is recommended.
