April 4, 2017

Report for Geotechnical Exploration Cardinal Valley Community Care Addition

Lexington, Kentucky

17-0151

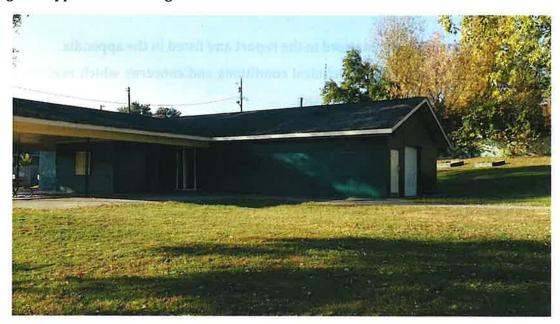
The site is considered to be generally level with ankle high grass. Based on visual observations, the subgrade appeared to be in good condition without obvious indications of standing water or obvious soft subgrade. Site drainage appeared to be adequate. The subgrade appeared to be in good condition.

Photograph 1 - Facing Proposed Development
