Date 06/27/2024
To LFUCG Historic Preservation
Cc Specs
From Gatton Park
Subject Proposed Renovation of Stone Walls
at Gatton Park

The purpose of this memo is to summarize the issues surrounding the historic stone walls at Gatton Park and the proposed remediation to make the area safe prior to park opening in summer 2025. This summary has been prepared by Sasaki in coordination with Strand SAI for Gatton Park and it is intended to facilitate communication with LFUCG Historic Preservation.

ISSUE SUMMARY

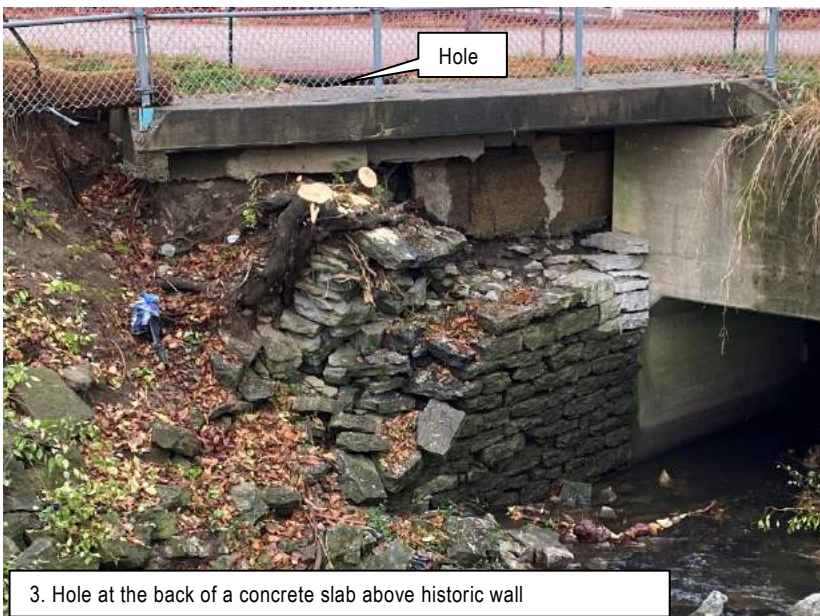
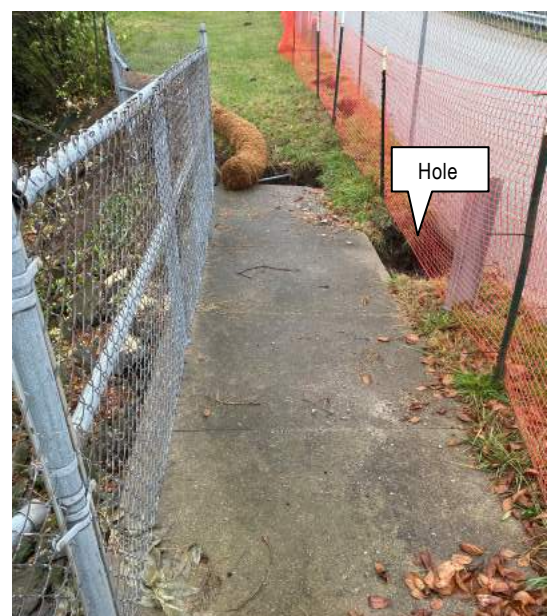
Photos of the current condition are included on p. 3.

- The dry stacked walls that are still standing are leaning in some areas and may fall at any time.
- The portions of fallen wall are not stable and are susceptible to continued erosion from both the creek and stormwater runoff.
- On the south side of the culvert, erosion has led to a hole at the back of a concrete slab. This condition is not feasible to fix without impacting the historic wall and fallen wall below.

Gatton Park discussed these points both internally and with landscape architects, civil engineers, structural engineers, historic wall specialist, and employees of LFUCG. Ultimately, Gatton Park determined that the solution that creates the most stable and desirable condition for the park is to salvage the historic stone, build structural retaining wall where needed along the creek, and use the historic stone to face the new structural wall.
