LEXINGTON-FAYETTE URBAN COUNTY GOVERNMENT CONTRACT CHANGE ORDER Page 1 of 2	Date:	November 16, 2015	
	Project:	Senior Citizen Center Construction	
	Location:	Lexington	
To (Contractor): Marrillia Design & Construction 259 West Short Street Suite 325 Lexington, KY 40507	Contract No.	227-2014	
	Original Contract Amt.	\$8,882,900.00	
	Cumulative Amount of Previous Change Orders	\$1,349,994.37	
	Percent Change - Previous Change Orders		15.20%
	Total Contract Amount Prior to this Change Order	\$10,232,894.37	
	Change Order No.	28

PROJECT	LFUCG Senior Citizens' Center 201333	DATE SENT	10/27/2015
SUBJECT	Entry Drive Subsurface Remediation	PROPOSAL REQUEST ID	PR-040
TYPE	Proposal Request	TRANSMITTAL ID	00713
PURPOSE	For Review and Response	VIA	Info Exchange

**Subject: Limited Exploration and Pavement Subgrade Recommendations
Lexington Senior Citizens Center – Idle Hour
St. Ann Drive
Lexington, Kentucky**

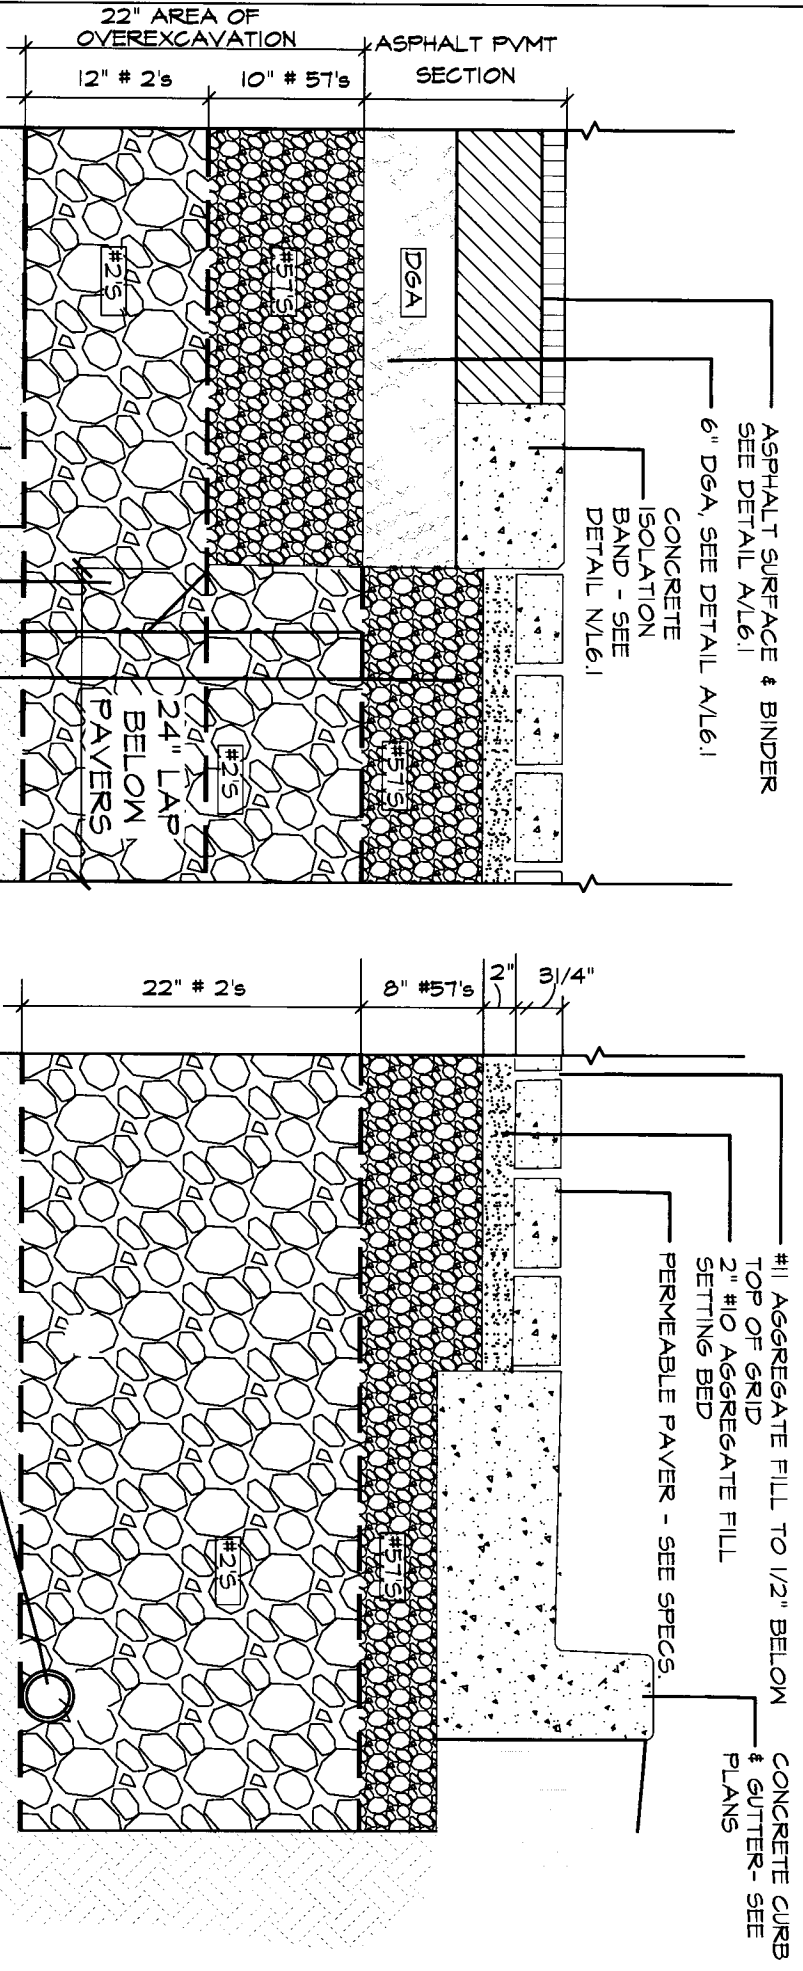
SHEET L6.1 R-1

GEOTEXTILE, TENSAR BX1200 OR APPROVED EQUAL, CONTINUOUS BETWEEN #2'S AND #57'S

#2 STONE - PLACE IN SINGLE LIFT

MOVEN HIGH PERFORMANCE GEOSYNTHETIC FABRIC, MIRAFI HP570 OR APPROVED EQUAL, CONTINUOUS

SLOPE SUBGRADE 1/8" / FT MINIMUM TO 6" PERFORATED DRAIN TILE AND BEYOND

- undercut below pavement subgrade by 24 inches
- install an 8" perforated pipe at the base of undercut as shown on attached sketch L10.0, drain to structure CI-6
- install stone and geotextile per PR-018 recommendations (similar to those used in main parking areas, see attached sketch)

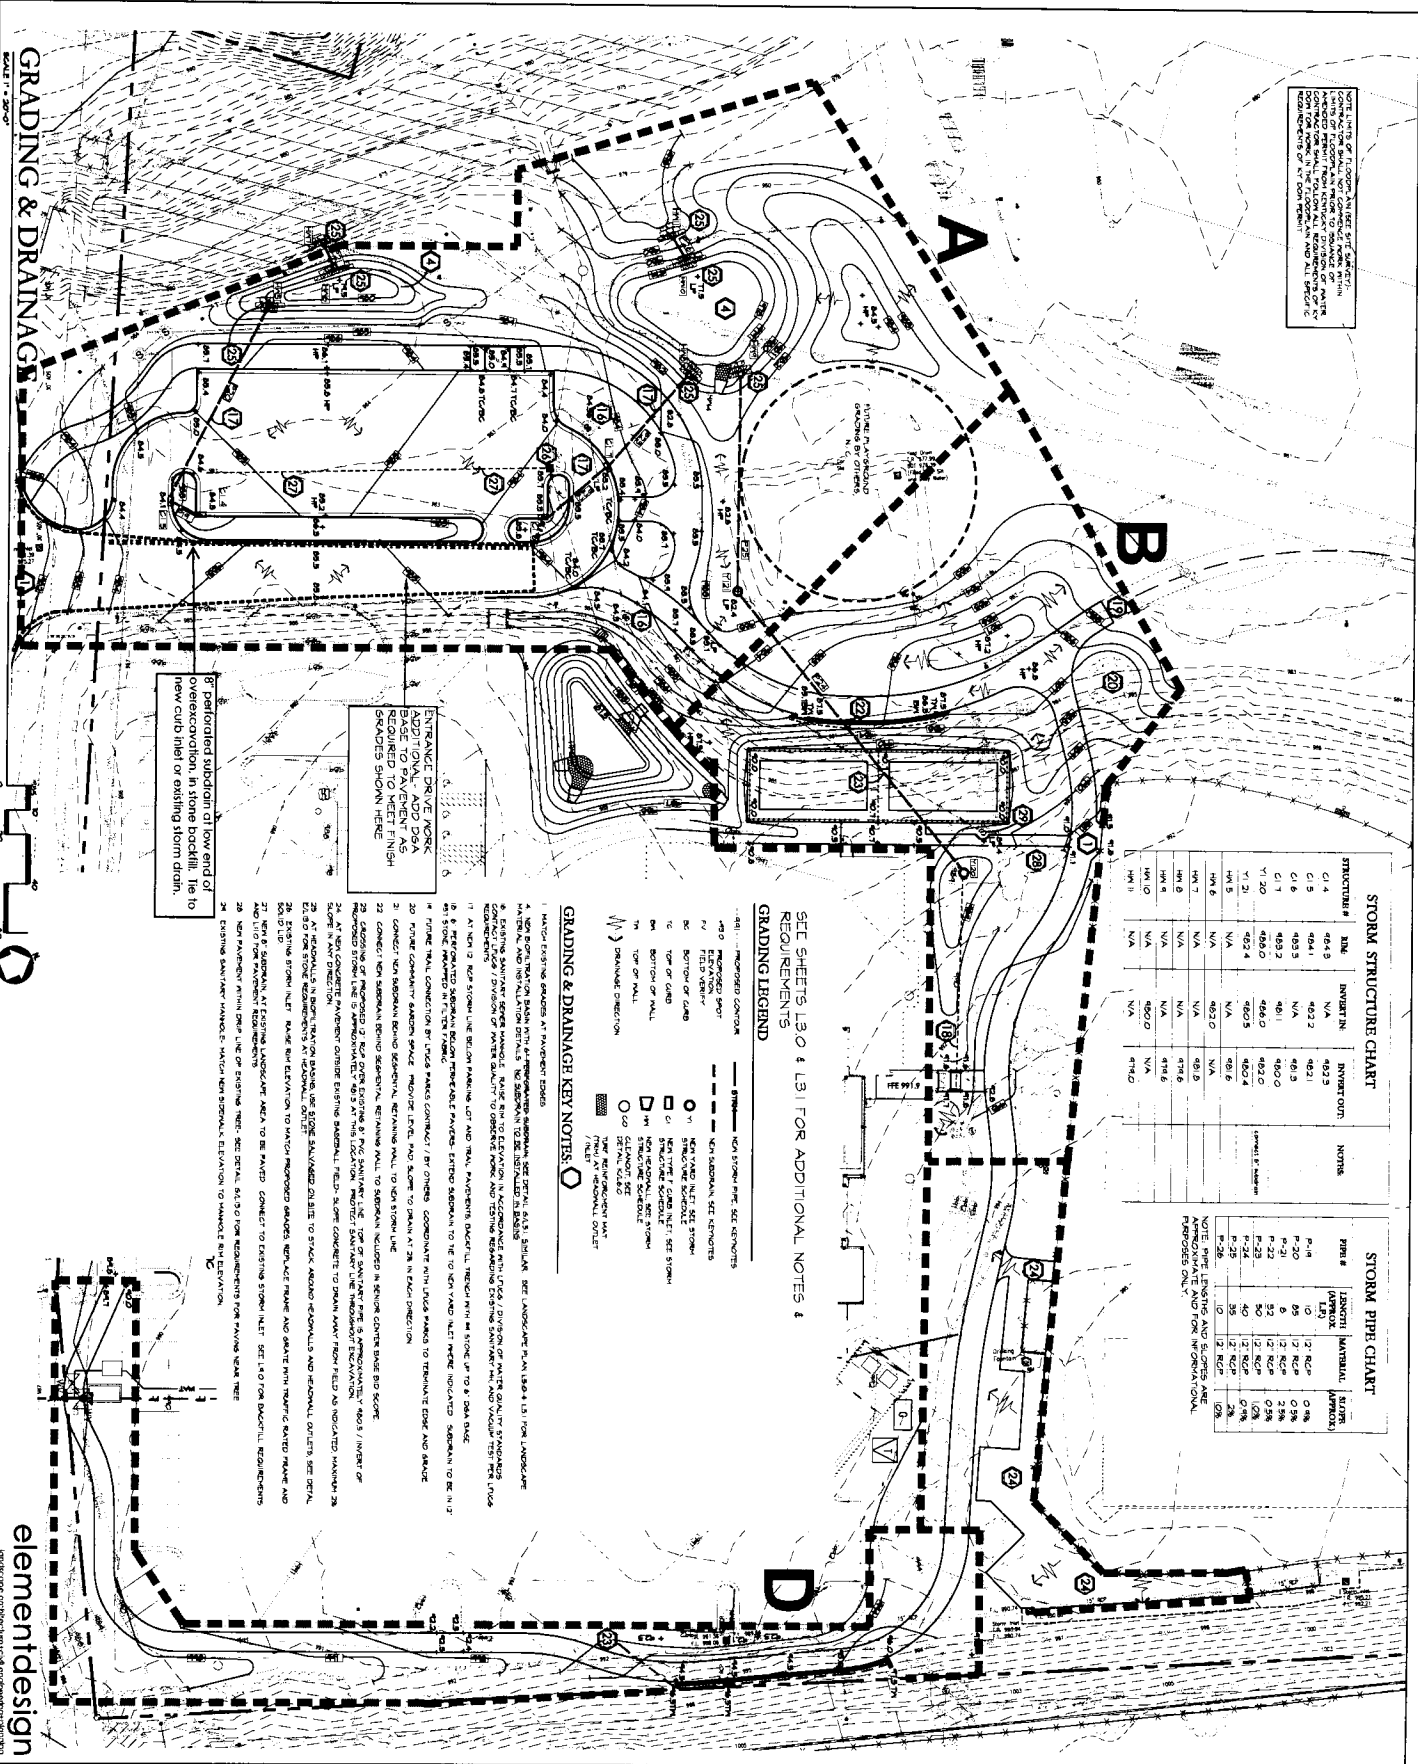
GRADING & DRAINAGE
SCALE: 1" = 20'-0"

16' perforated subdrain at low end of overexcavation, in stone backfill. Tie to new curb inlet or existing storm drain.

ENTRANCE DRIVE WORK
ADDITIONAL ADD DATA
BASE TO PAVEMENT FINISH
GRADES SHOWN THERE
