Pending Owner Approval
PR-53 Cost to Remediate the Subsurface Grades Below the Paving Subgrade at the Life Lane Entry Drive per Proposal Request No. 40 - Revision #1

PROJECT	LFUCG Senior Citizens' Center 201333	DATE SENT	10/27/2015
SUBJECT	Entry Drive Subsurface Remediation	PROPOSAL REQUEST ID	PR-040
TYPE	Proposal Request	TRANSMITTAL ID	00713
PURPOSE	For Review and Response	VIA	Info Exchange

SHEET L6.1 R-1

**Subject: Limited Exploration and Pavement Subgrade Recommendations
Lexington Senior Citizens Center – Idle Hour
St. Ann Drive
Lexington, Kentucky**

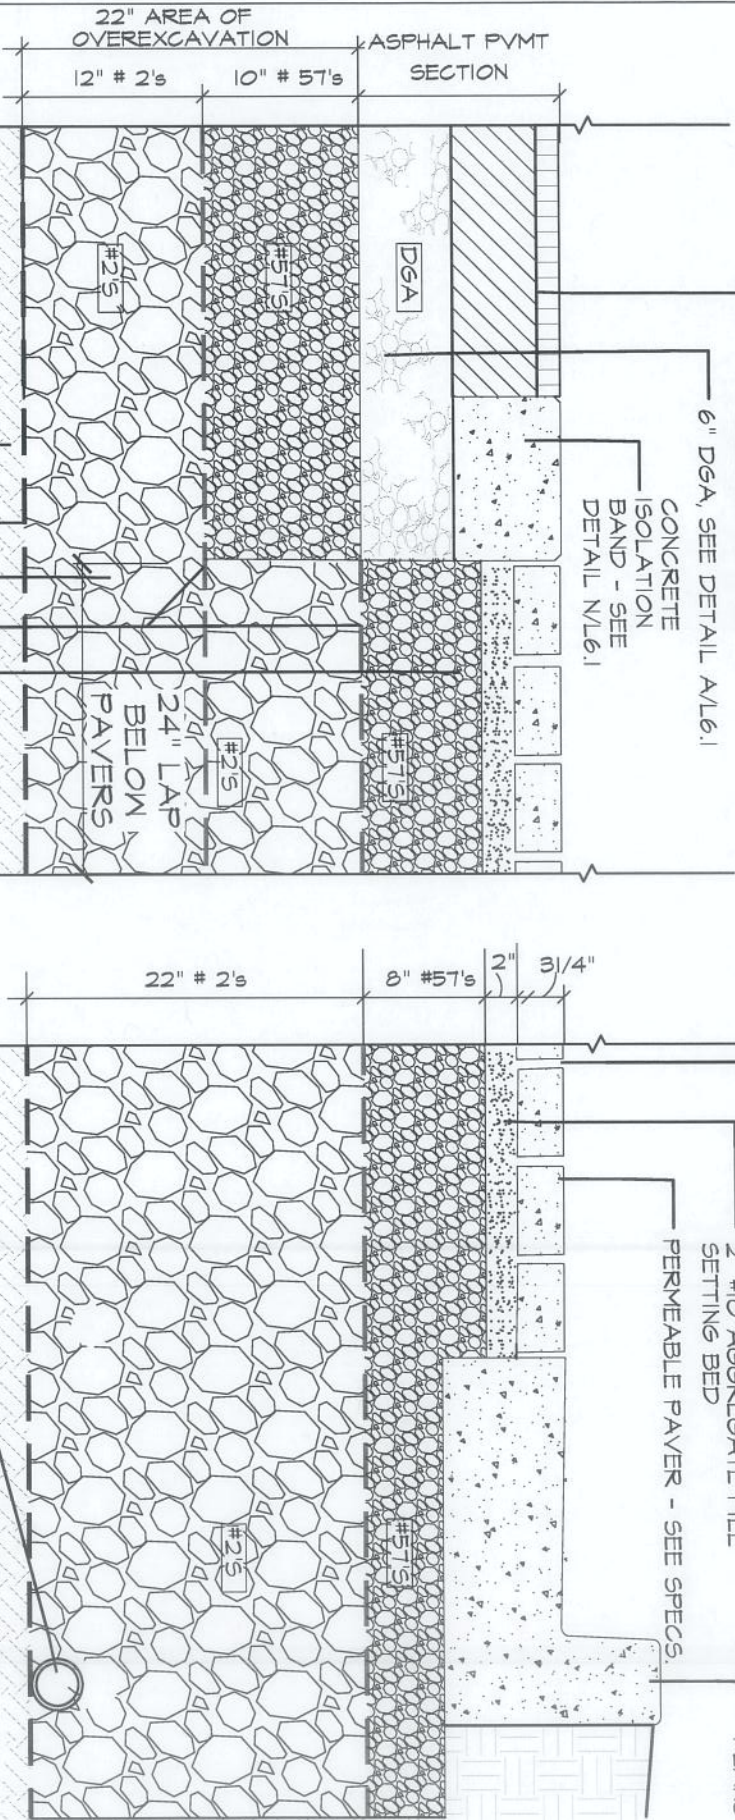
22" AREA OF OVEREXCAVATION
SECTION

8" PERFORATED PIPE IN STONE, SLOPE 1/8"/FT

#57 STONE, PLACE IN SINGLE LIFT

GEOTEXTILE, TENSAR BX1200 OR APPROVED EQUAL, CONTINUOUS BETWEEN #2'S AND #57'S

#2 STONE - PLACE IN SINGLE LIFT
NOVEN HIGH PERFORMANCE GEOSYNTHETIC FABRIC, MIRAFI HP570 OR APPROVED EQUAL, CONTINUOUS

SLOPE SUBGRADE 1/8" / FT MINIMUM TO 6" PERFORATED DRAIN TILE AND BEYOND

Please provide pricing to remediate the subsurface grades below paving subgrade at the Life Lane entry drive, per recommendations by the geotechnical engineer. Site observation has shown the entire entry drive area designated for heavy duty pavement (per sheet L4.1) is unstable under construction traffic, and the recommendation is as follows:

- undercut below pavement subgrade by 24 inches
- install an 8" perforated pipe at the base of undercut as shown on attached sketch L10.0, drain to structure CI-6
- install stone and geotextile per PR-018 recommendations (similar to those used in main parking areas, see attached sketch)

- install heavy duty asphalt paving (6" DGA, 5 1/2" base course, 1 1/2" surface course) over compacted sub-grade stone per A/L6.1
