LEXINGTON-FAYETTE URBAN COUNTY GOVERNMENT CONTRACT CHANGE ORDER Page 1 of 2	Date:	November 16, 2015
	Project:	Senior Citizen Center Construction
	Location:	Lexington
To (Contractor): Marrillia Design & Construction 259 West Short Street Suite 325 Lexington, KY 40507	Contract No.	227-2014
	Original Contract Amt.	\$8,882,900.00
	Cumulative Amount of Previous Change Orders	\$1,349,994.37
	Percent Change - Previous Change Orders	15.20%
	Total Contract Amount Prior to this Change Order	\$10,232,894.37
	Change Order No.	28

PROJECT: Senior Citizen Center Construction

CHANGE ORDER NO. 28

PROJECT	LFUCG Senior Citizens' Center 201333	DATE SENT	10/27/2015
SUBJECT	Entry Drive Subsurface Remediation	PROPOSAL REQUEST ID	PR-040
TYPE	Proposal Request	TRANSMITTAL ID	00713
PURPOSE	For Review and Response	VIA	Info Exchange

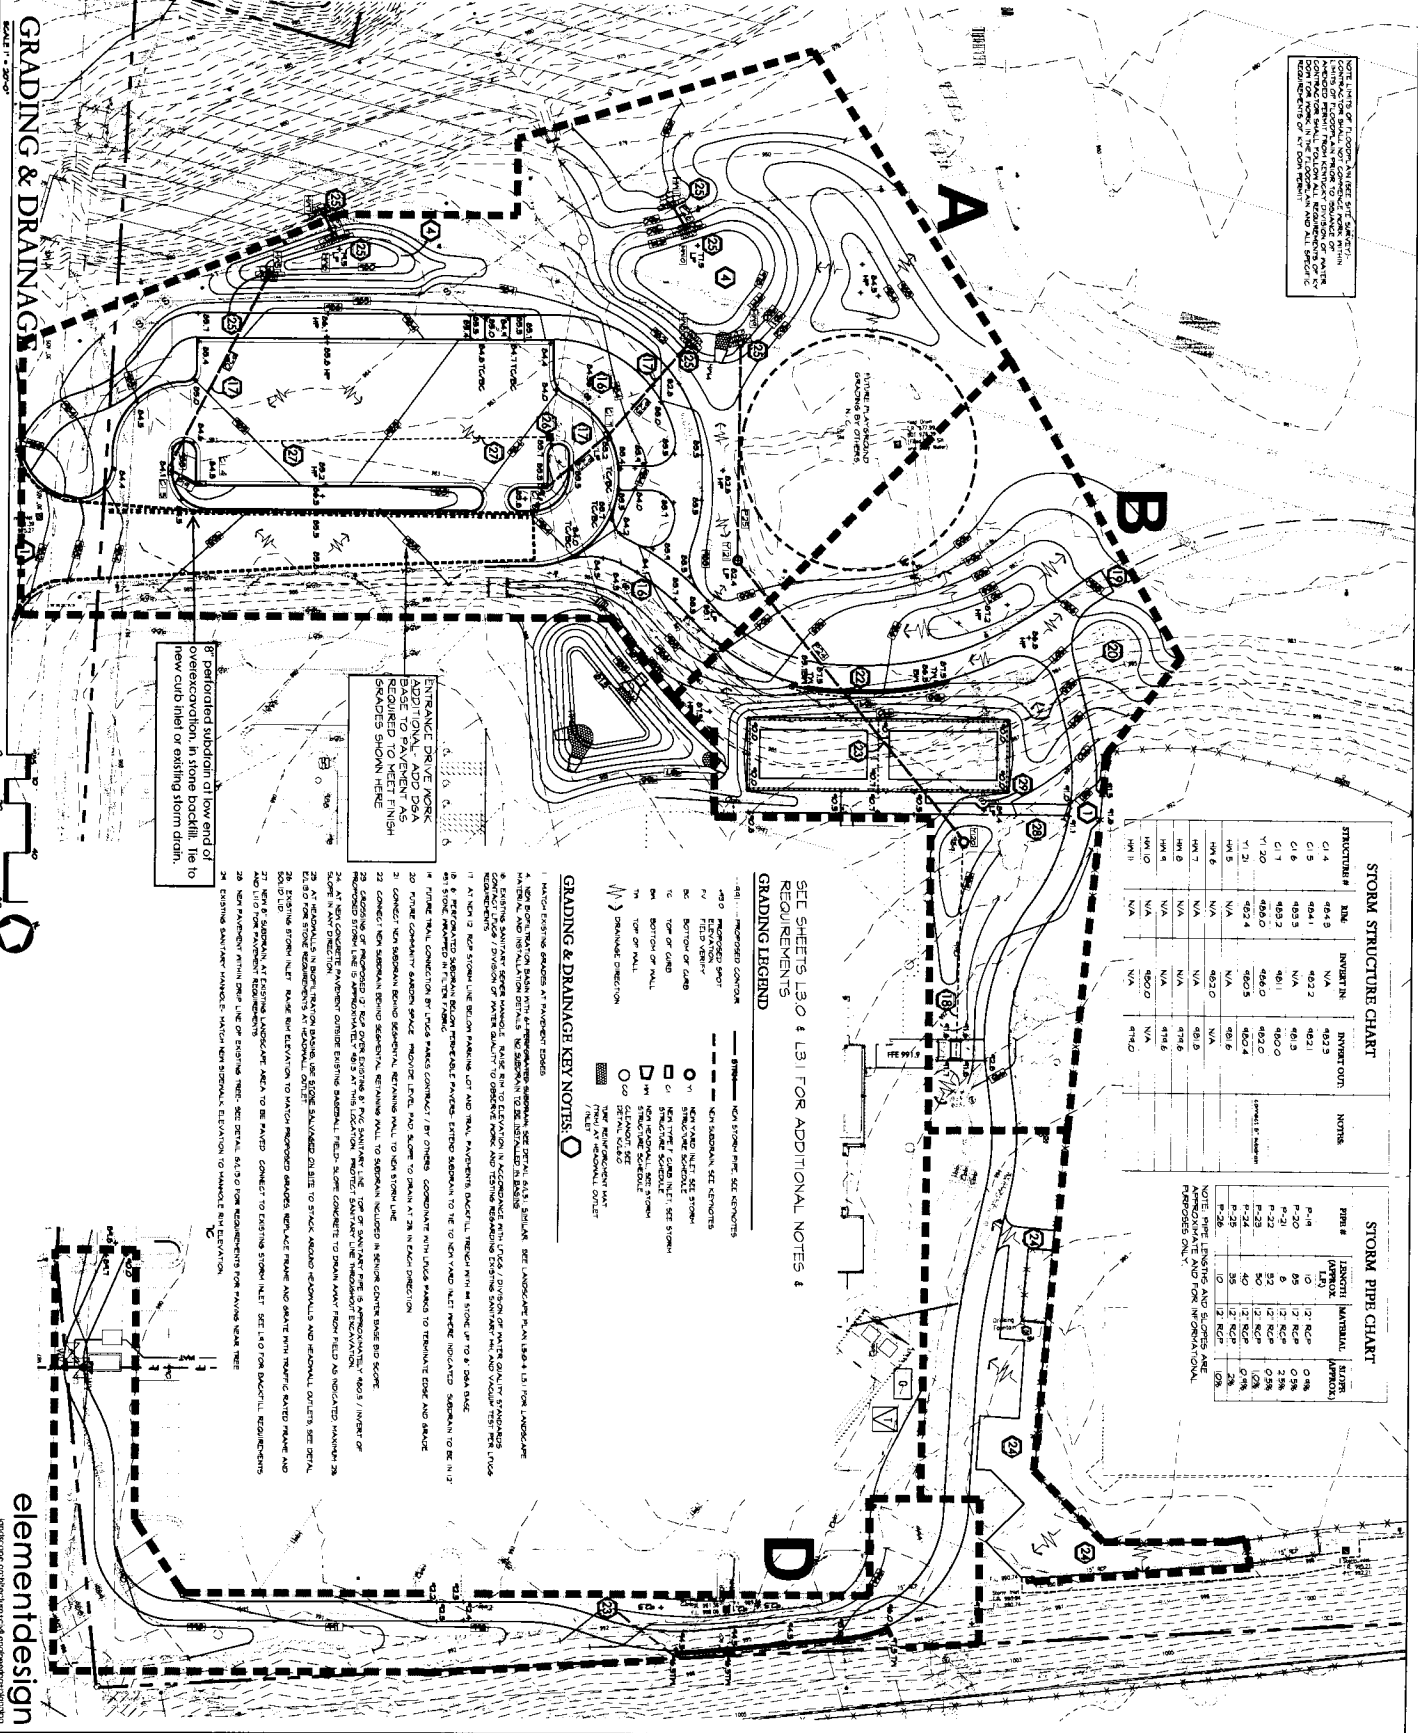
GRADING & DRAINAGE

ENTRANCE DRIVE WORK ADDITIONAL. ADD DATA BASE TO PAVEMENT AS SHOWN IN FINISH GRADES SHOWN HERE.

perforated substratum at low end of overexcavation in stone backfill. Tie to new curb inlet or existing storm drain.
