**From:** Greg Meegan <gmeegan@tri-stateservice.com>  
**Sent:** Sunday, May 21, 2017 9:41 PM  
**To:** 'Margie Jacobs'; Bettie Kerr  
**Cc:** Jamshid Baradaran; Mark Arnold; Jim Powell; Jessica Walker  
**Subject:** RE: Black & Williams Center Cornice Replacement

**From:** Greg Meegan [<mailto:gmeegan@tri-stateservice.com>]  
**Sent:** Monday, May 22, 2017 12:44 PM  
**To:** 'Margie Jacobs' <[margie@thjarch.com](mailto:margie@thjarch.com)>  
**Subject:** Black & Williams Roof Area 3 Deck Replacement

Black & Williams Roof Replacement: Masonry Damage

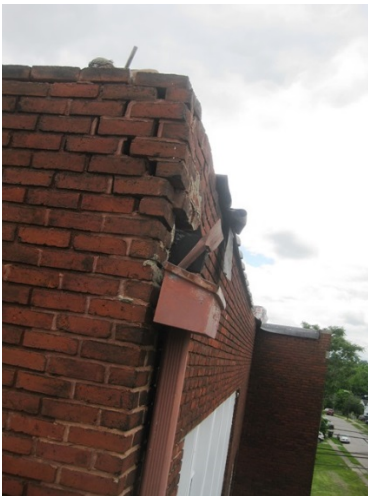
North corner of Roof Area 1

They also uncovered the last through wall scupper and in the process the north corner became unstable, and the masonry wall shifted on them.

The left rear scupper of the uppermost roof has severe existing damage. We are responsible under the original contract to slightly enlarge this opening. When the flashing was removed the inner and outer wythes of brick moved outward and are in danger of falling. Some coping was removed and the top courses of the brick are loose and also need to be reset in mortar.

The deterioration in this section requires that we dismantle the area around the scupper from the roof deck to and including the coping around the corner of the wall in both directions. All work will be according to existing specifications.

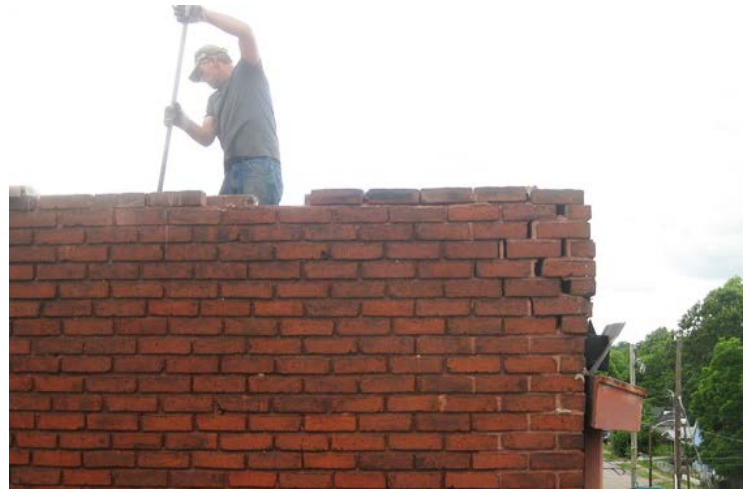
North corner of Roof Area 1: approx. 6' of clay tile copings came off during roof tear off

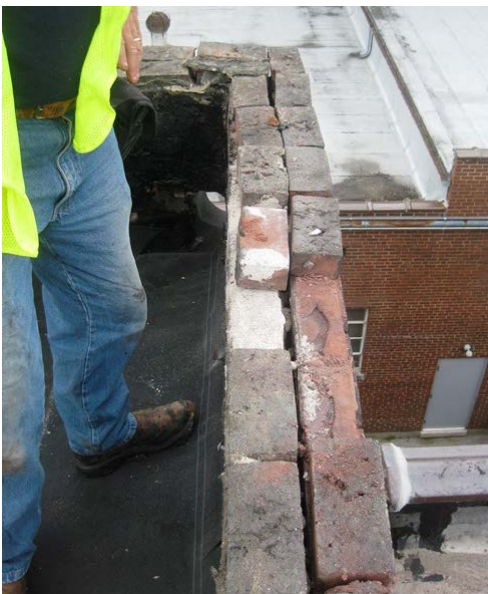
North corner of Roof Area 1: mortar is gone

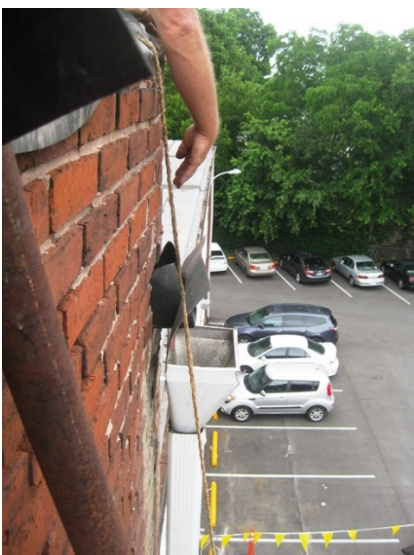
The right rear scupper of the uppermost roof has severe existing damage. We are responsible under the original contract to slightly enlarge this opening. When the flashing was removed it became apparent that all of the mortar is disintegrated above the scupper. The brick have dropped out of place on the interior wythe and the exterior wythe has shifted outward approximately one and one half inches. The deterioration in this section requires that we dismantle the area around the scupper from the roof deck to and including the coping. We will rebuild the wall with matching mortar and install a quarter inch thick flat iron above the scupper opening. This work will be done from an aerial lift platform for safe access at the corner.

S. Corner of Roof Area 1: partial repairs have been made.

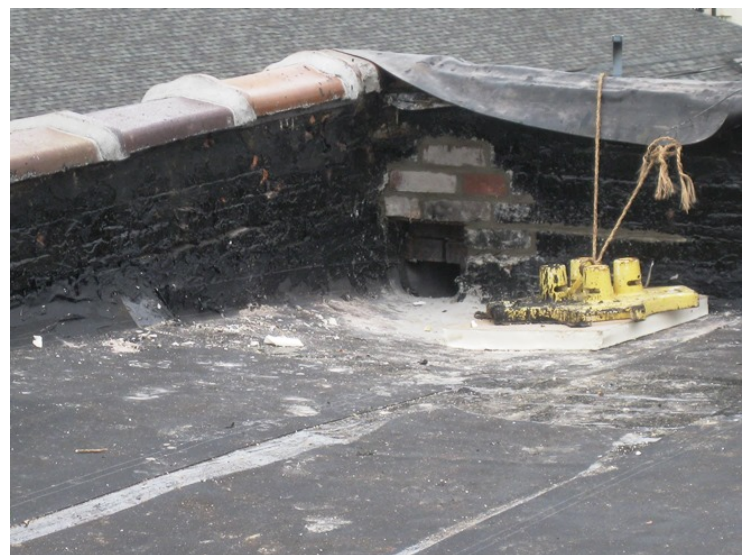
S. Corner: Roof is dried in with increased sump & slope to scupper.
