# Lexington-Fayette Urban County Government

The Lexington-Fayette Urban County Government hereby requests proposals for **RFP #16-2025 Site Development of the Fire Training Academy Campus Phase I** to be provided in accordance with terms, conditions and specifications established herein.

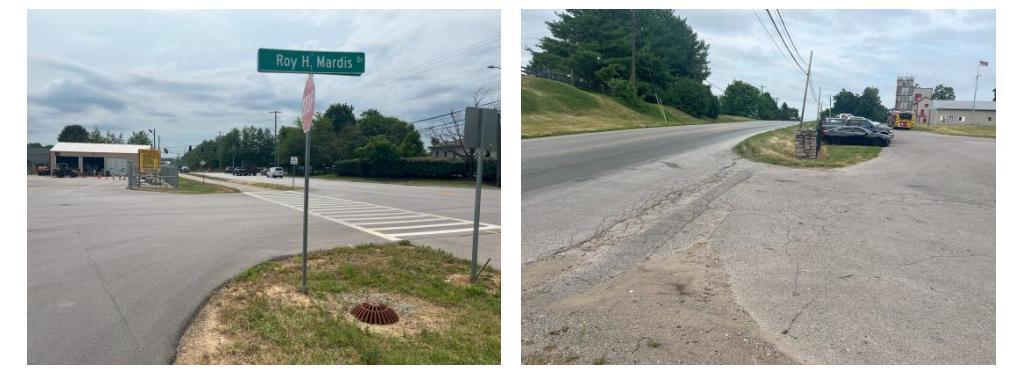
1. The site is located on the North side of Frankfort Pike. There are three access points into the site. All three are asphalt. The first 25% (east) of the site, Trail Branch has been extended. That project was recently completed. The first entrance has proper traffic control (cross walk, stop sign, etc., the other two are wide and shallow and lack any controls.

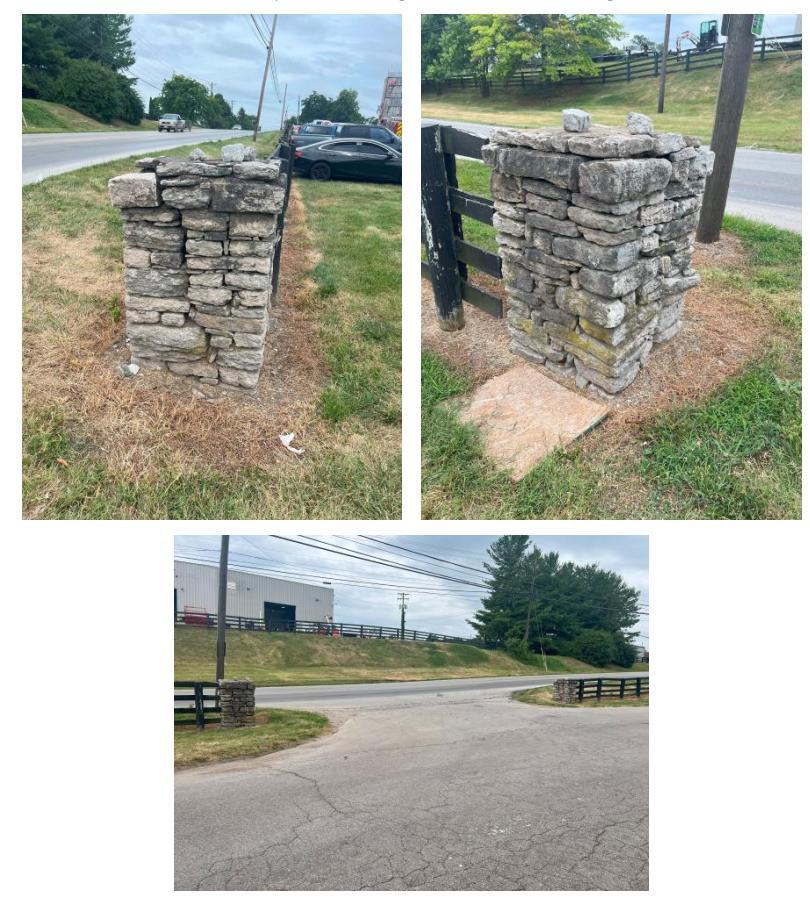
2. Moving west on Frankfort Pike there is an old four plank fence that extends the length of the site, it is in need of minor repair and repainting. There are also two dry stacked stone masonry pillars, one of which is in need of repair. It may have been hit by a vehicle at some point.

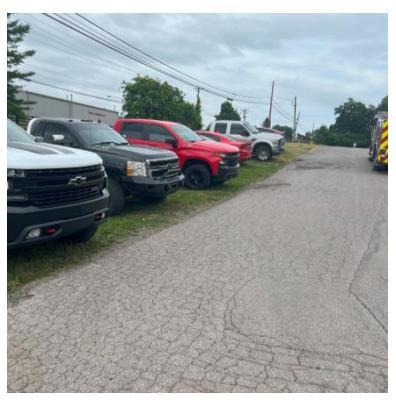
4. Moving west on the site there is a fair number of classes going on at the facility today. A lot of vehicles are parked on the grass towards Old Frankfort Pike. If this area is to be used for parking regularly, the area should be paved, or better stabilized with grass pavers.

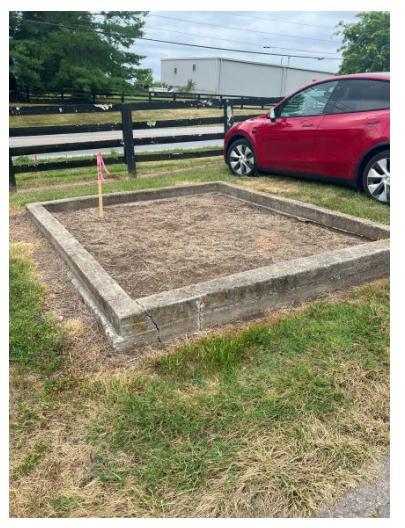
5. There is an old foundation in that same area that does not appear to be used at this time. It is recommended that the foundation be removed.

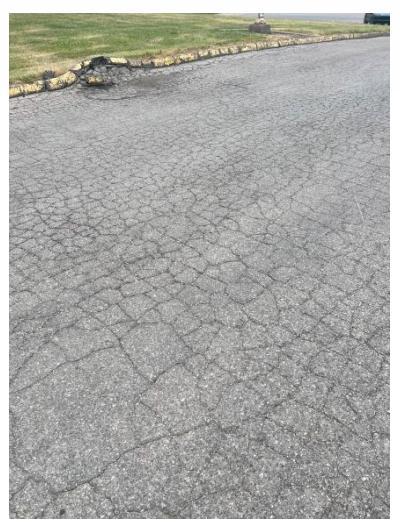
6. The drive from the main training facility building to west training areas is in need of replacement, it is evident that the subgrade has failed. The asphalt pavement is cracked and "alligatored".

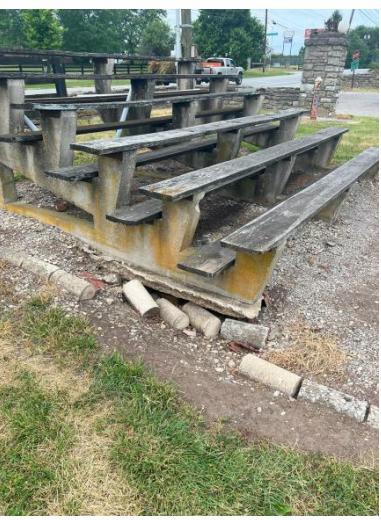
7. There is an old set of bleachers between the facility. There is some undermining of the foundation occurring due to storm water runoff, if the bleachers are being used, the foundation should be repaired, if they are unused, it is recommended they be removed.

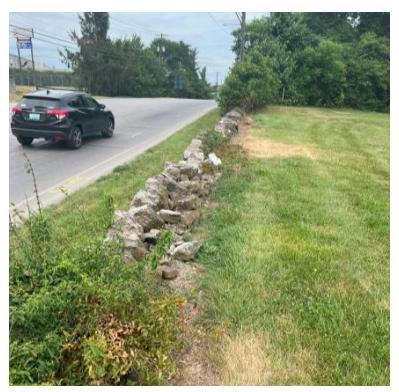
8. The rock wall on the western most entrance is beginning to fail and deteriorates more as you move westward.

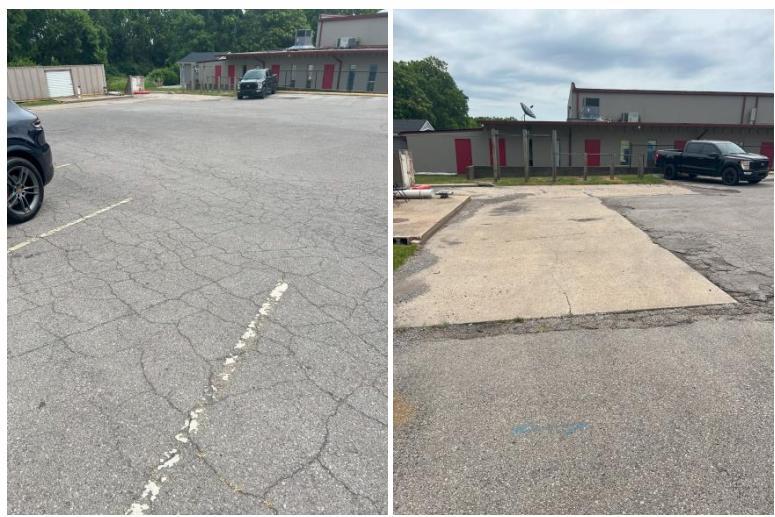
9. Moving to the parking lot on the left side of the same building, again the asphalt is older and there is a lot of cracking signifying failure of subgrade. Three is a water storage tank and shed at the end of the lot.

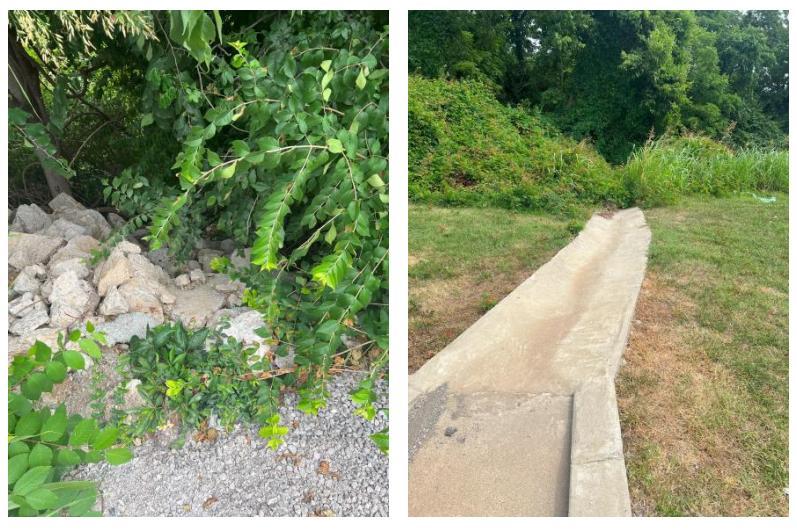
10. Runoff from storms is directed towards one corner of the parking lot and drains directly into Town Branch. It is recommended that storm water runoff be sent through a water quality unit. Storm water quantity should be looked at as well, but as a broader look at the Town Branch Watershed.

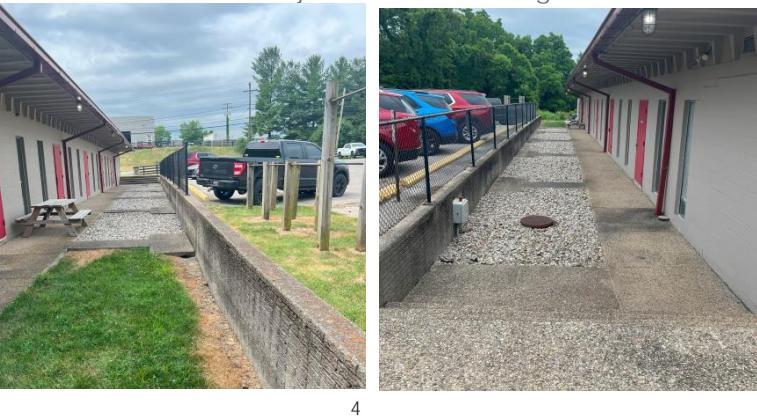
11. On the west side of the building there is a small retaining wall adjacent to the parking area. It is in fair condition. The fence/rail on top of it stretches along the parking area and is in good condition. The concrete adjacent to the building is in fair condition.

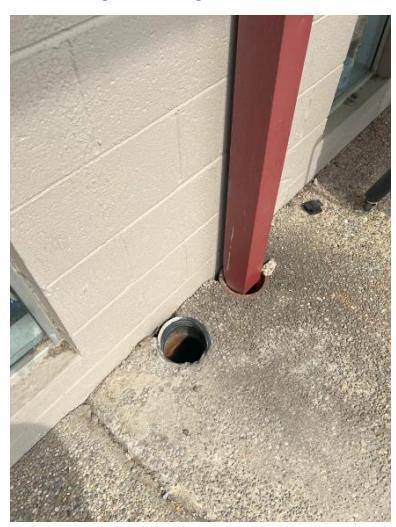
12. The downspouts are connected to underground storm system. I did not see an indication of where that storm pipe leads, most likely directly to Town Branch.

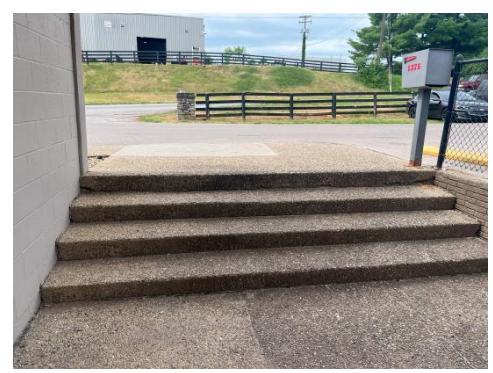
13. On the west side of the building at the front there is a set of four steps. There are no handrails on these steps. It is recommended that handrails be added to meet current codes.

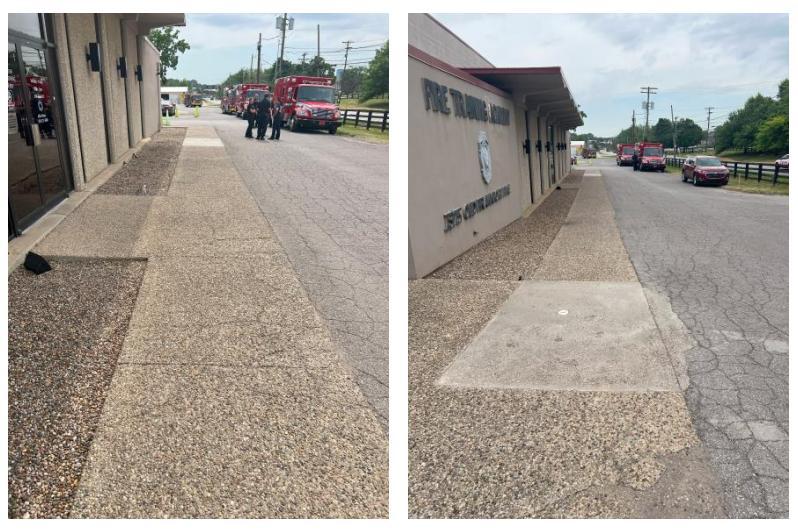
14. On the front side of the building there is sidewalk about 4' off the face and in fair condition. There is no curb so it is flush with the asphalt, therefore no ADA ramps but there is also no tactile warning strips at the front of the building.

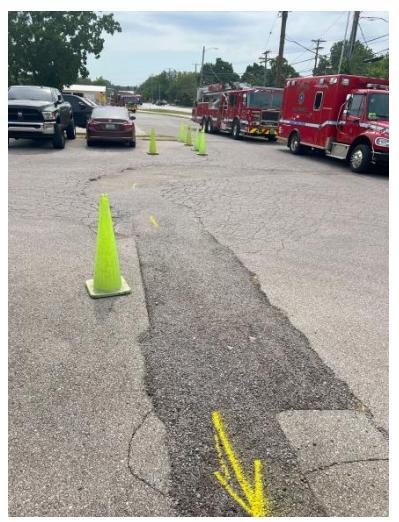
15. Moving to the east side of the building there is a parking lot that is adjacent to the building. Asphalt is again in the same similar condition. May be a little more wear and there is some recent repairs for a gas line installation.

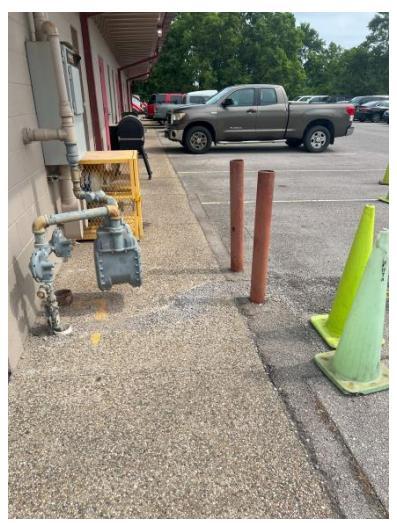
16. The sidewalk on the east side of the building is in similar condition to the other walks. Downspouts again are in good condition and lead to a pipe most likely draining to Towns Branch.

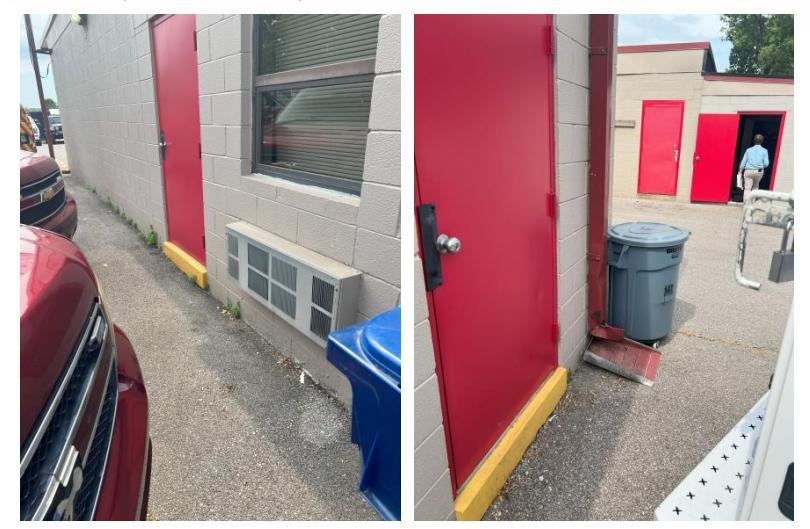
19. Moving on the backside of the building there is an additional asphalt parking area that extends straight up to the building. There is no sidewalk in this area. The rear two doors have a six-inch step down as you exit. There is a downspout here that has been damaged and splashes directly onto the asphalt pavement. It is recommended to install concrete stoops at these locations and repair the downspout.

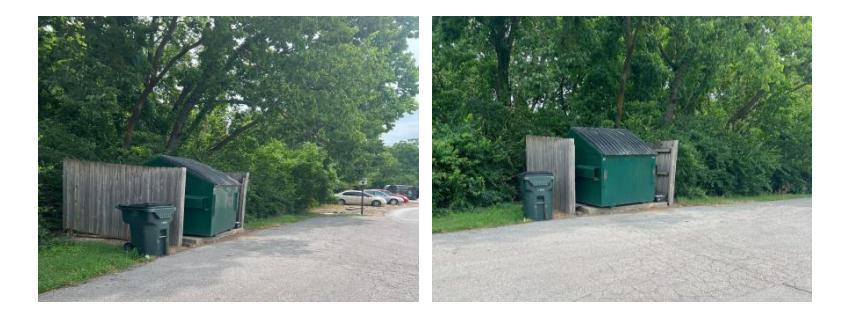
20. There is a dumpster pad at the rear of the building and a surround, the surround is in poor condition. There are no gates for this and there is no concrete pad for the truck to stop and maneuver on. However, the asphalt has held up remarkably well considering. Location could be improved. At least the angle for the approach of the dumpster should be modified.

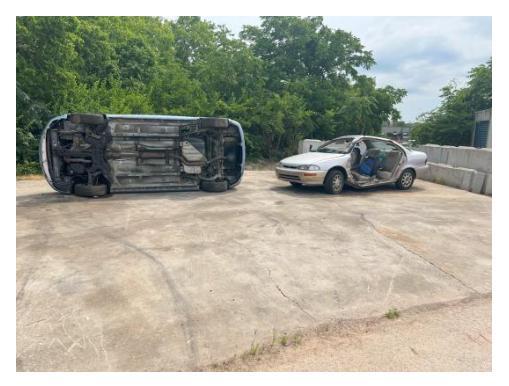
21. Moving over into the adjacent parking lot to the east, this parking lot is for using cars for training. Asphalt is in good condition in this area, concrete pads are in fair to good condition considering their intended use.

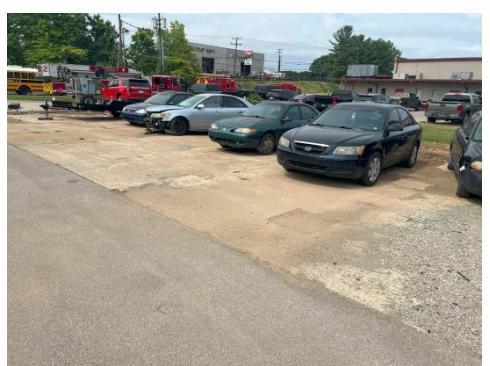
22. In this parking area there is some remnants of an old foundation. It is used for their training vehicles. It is in poor to fair condition.

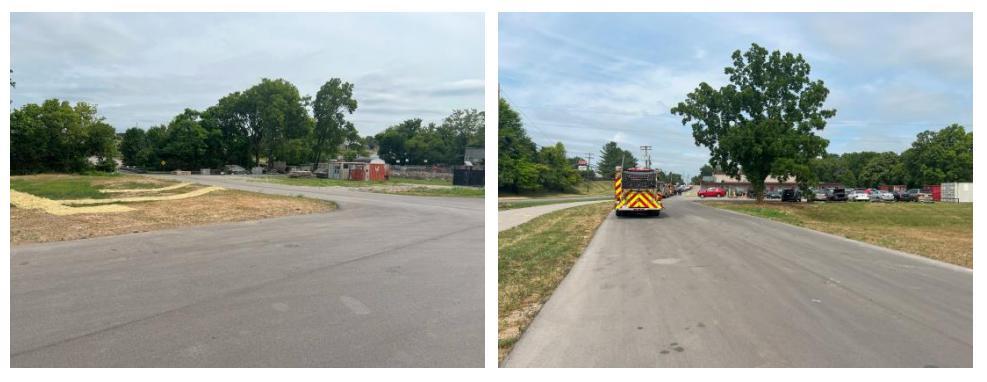
23. As we move on down to the bridge crossing into the rear area, the asphalt here is in good condition and was just repaved when they extended the trail.

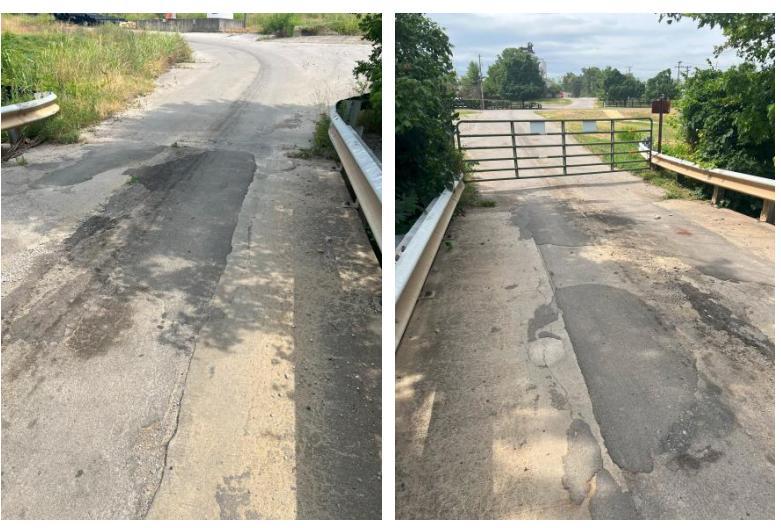
24. The bridge over Town Branch has been condemned and will need to be replaced.

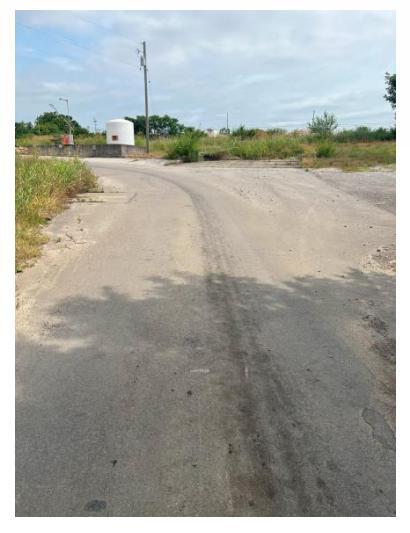
25. Drives leading up to and from the bridge are in fair condition.

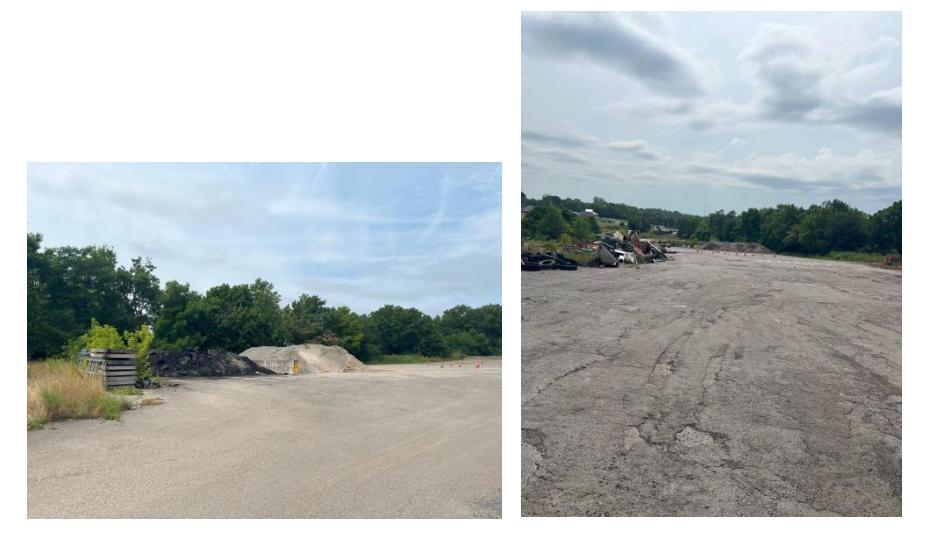
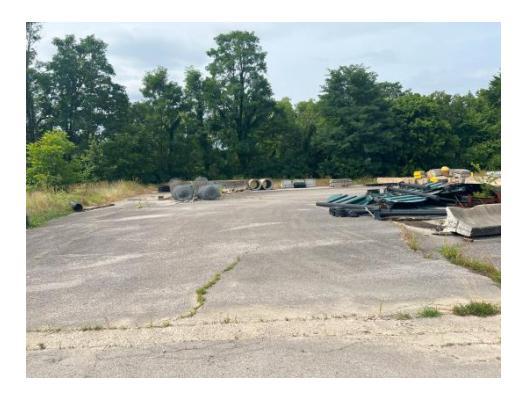
26. The property on the back side of Town Branch, between the creek and the railroad is an old storage yard for various materials. Mostly paved asphalt in fair to good condition until you get to the top where it turns more into ashalt in poor condition and then just straight into gravel.

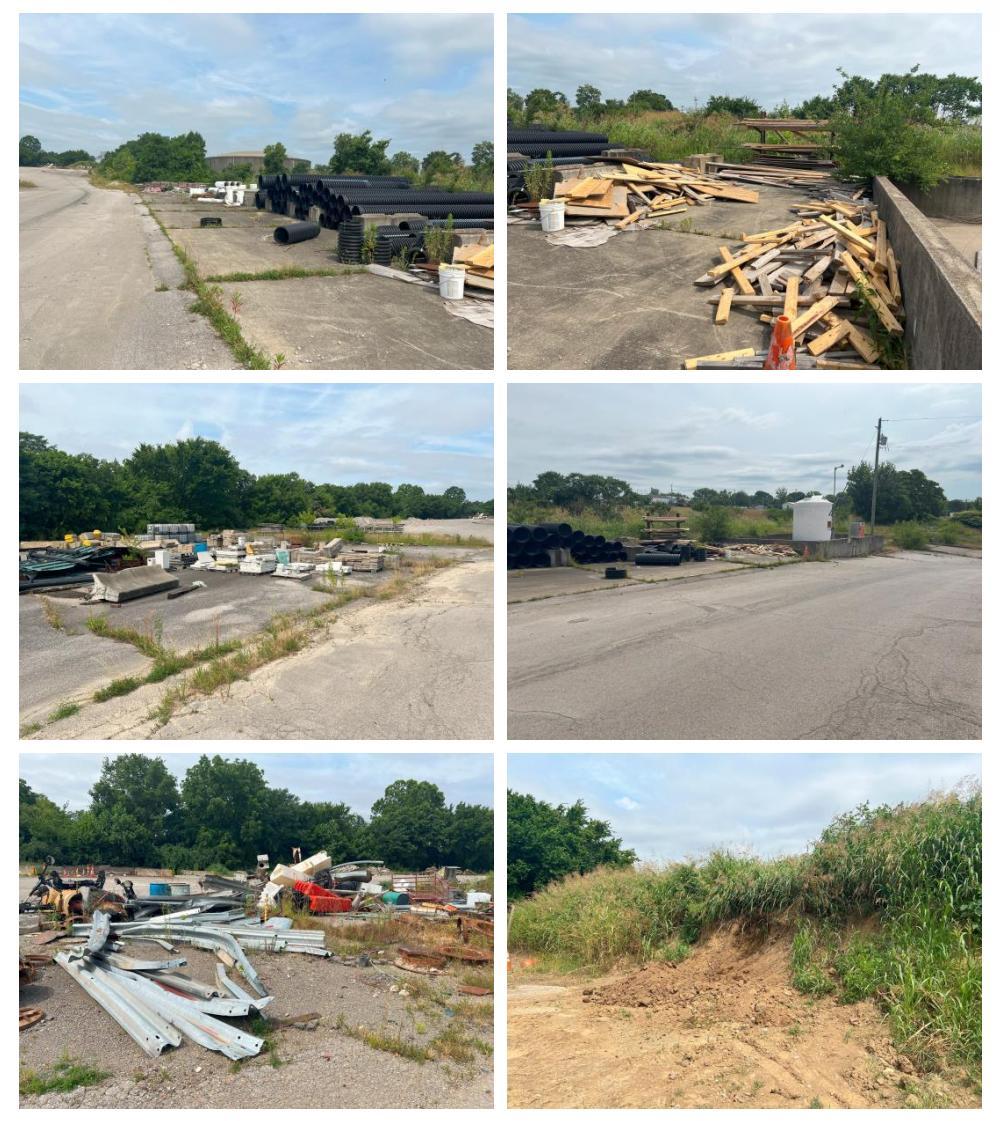
27. Adjacent to the asphalt areas are various concrete foundations and bins. Various types of materials gravel, soils, mulch, bricks and other items. This area slopes rather gently from the bridge, westward up behind the fire training facility. Slope is never great but is probably an estimated 20' rise. At the very top of the upper area is a large soil stockpile and more various materials. Topsoil earth is just old waste material and appears to be rather good soil.

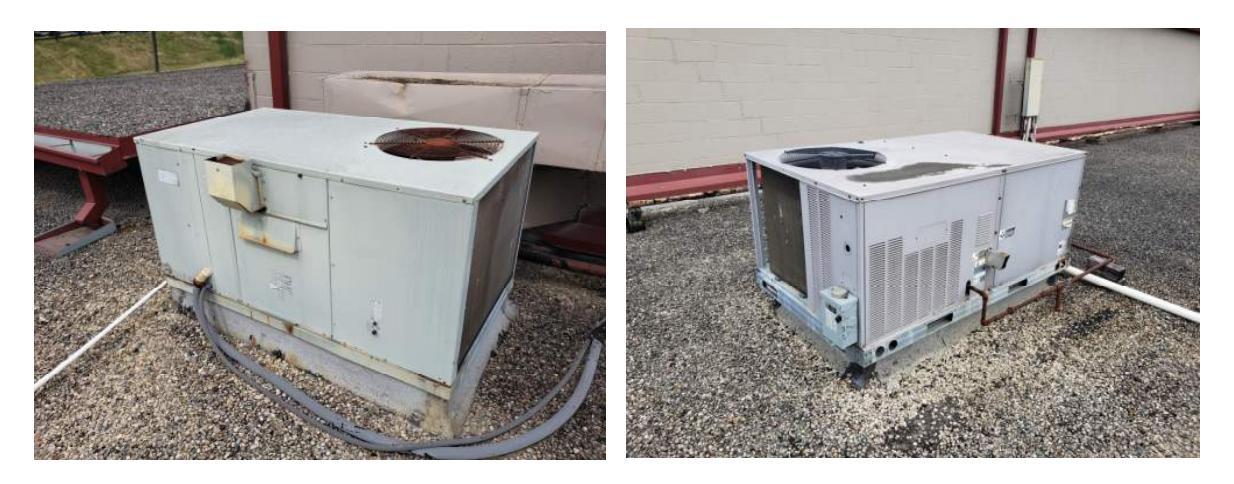
Images #01 & 02: Rooftop Units

The ductwork for the rooftop units appears to be original. Above ceiling, it appears that the supply ductwork is externally insulated while the return ductwork is internally lined. Due to the age of the ductwork and internal conditions, it is Paladin's recommendation that the ductwork be replaced.

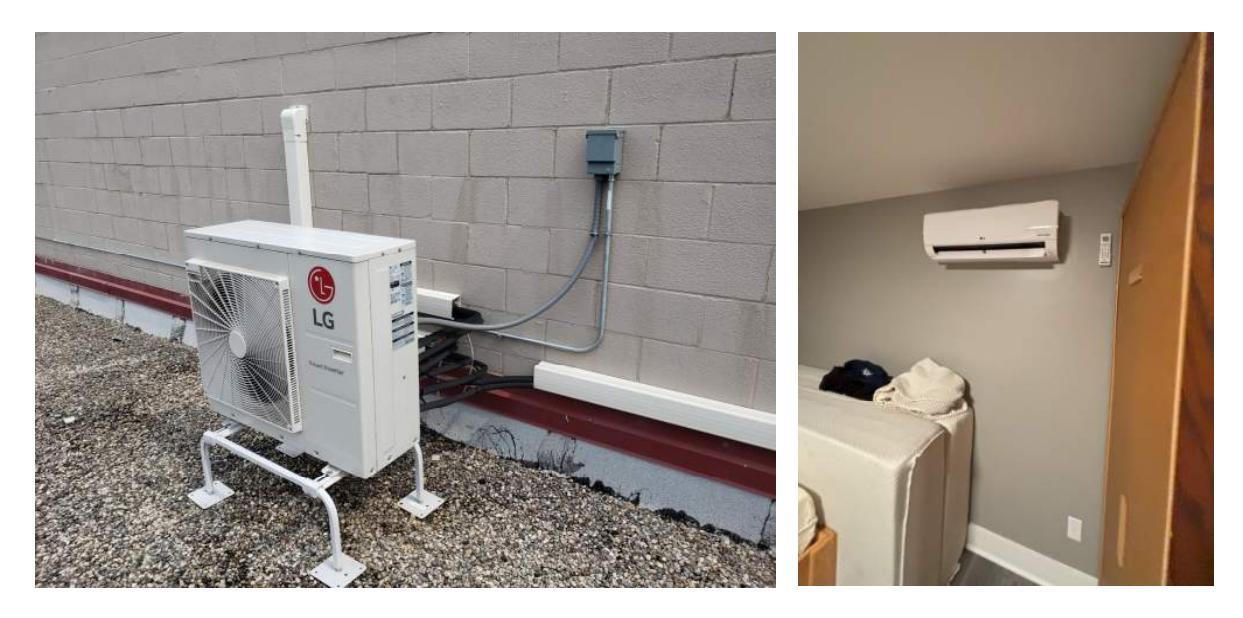
Images #03 & 04: Heat Pump System - Outdoor Unit and Indoor Unit

The new addition of the office spaces and bunks is served by a mini-split system heat pump. This features one outdoor unit mounted on the roof and four indoor units serving each of the four newly added spaces. This system and addition were installed in 2023, so the mechanical equipment has effectively its whole operating life remaining. If the programming of this addition does not change, it is not advisable to replace the mechanical systems in the new addition area.

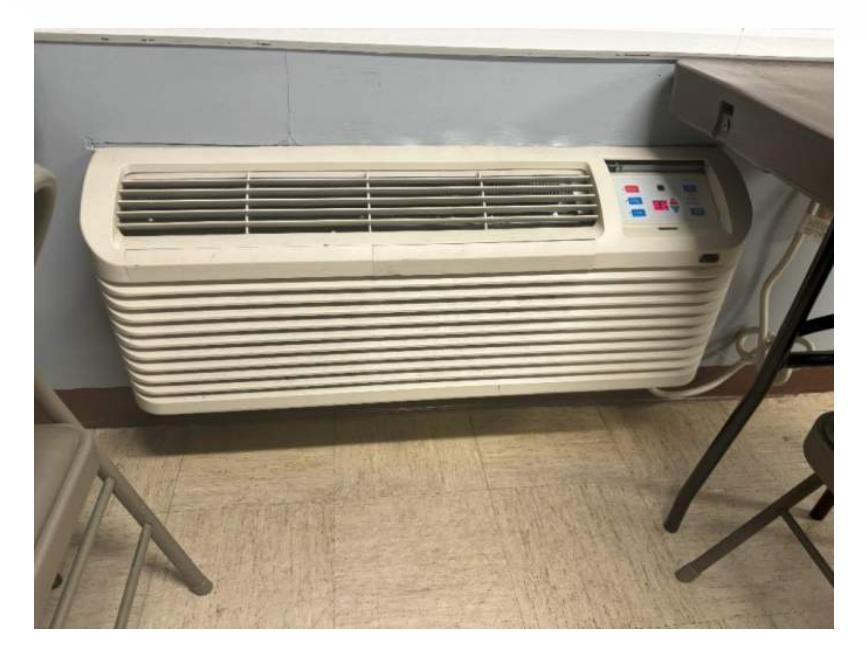
Image #05: PTAC Unit

Classroom 2 and the adjacent EMS Room are each served by a packaged terminal air conditioner (PTAC) unit. The PTAC units are estimated to have been installed in 2001. According to ASHRAE's life expectancy for the PTAC units, both are almost a decade past their life expectancy. Due to this, Paladin recommends the replacement of the PTAC units.

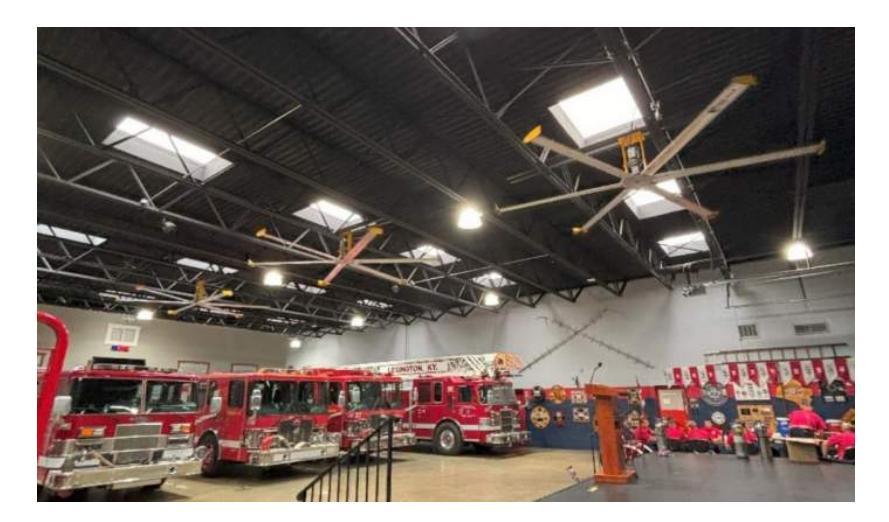
Image #06: HVLS Fans

The Bay is currently served by three high volume low speed (HVLS) fans. The estimated installation date for the HVLS fans was 2016. The ASHRAE life expectancy for these fans indicates that they have twelve years of operating life remaining. With over half of their lifetime remaining, it is Paladin's recommendation that these fans continue operating unchanged. Even if the air distribution is altered for the Bay, these fans will continue to combat thermal stratification that can more easily affect an area like the Bay with high ceilings.

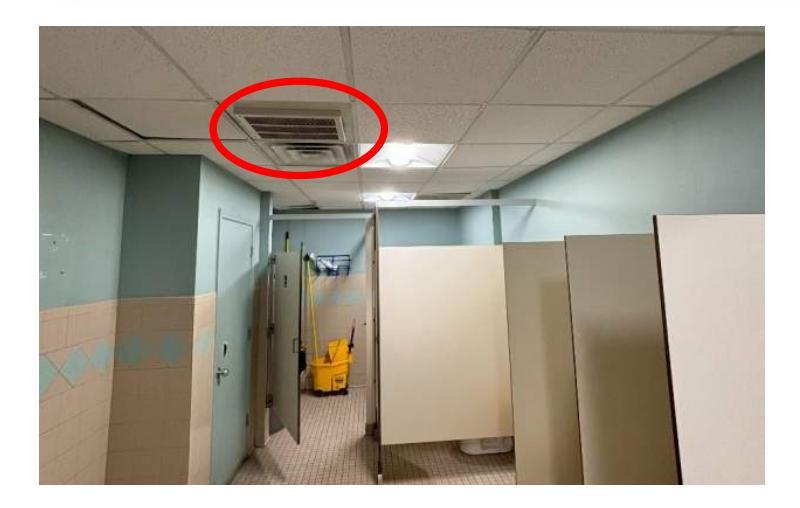
Image #09: Restroom Unit Heater

The men's and women's restrooms each have a ceiling mounted electric unit heater. It is estimated that these were installed when the restrooms were renovated in 2009. The ASHRAE life expectancy for these heaters indicates that they are past their operational life expectancy by two years. Due to this, it is Paladin's recommendation that the unit heaters be replaced.

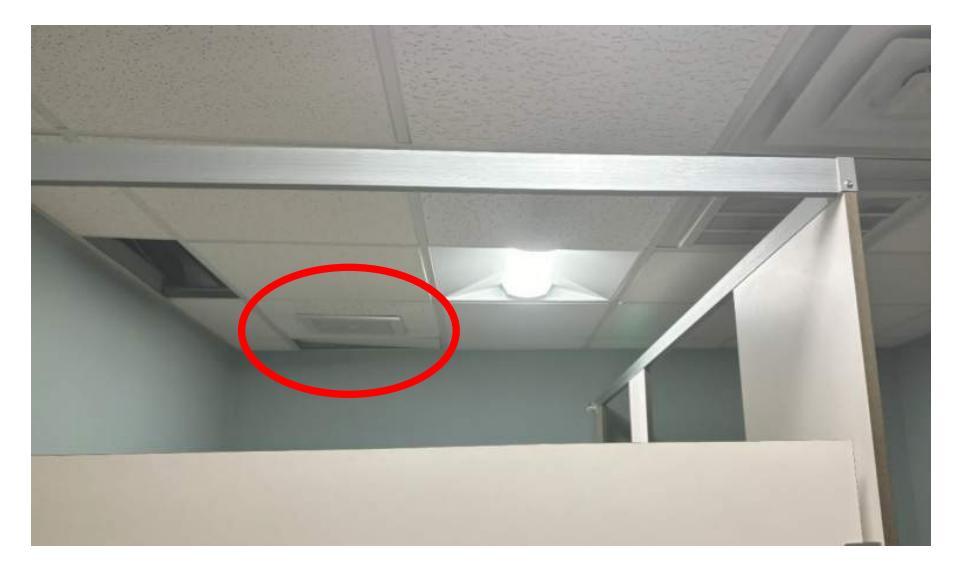
Image #09: Restroom Exhaust Fan

The three restroom areas: men's, women's, and Chief's, all include ceiling mounted exhaust fans. It is estimated that these fans were installed when the restrooms were renovated in 2009. The ASHRAE life expectancy for these fans indicates that they have approximately five years of remaining operational life. It is Paladin's recommendation that the restroom exhaust fans be replaced. The fans are nearing the end of their 20-year life expectancy and replacing them during the upcoming project is safer than allowing them to exceed their life expectancy and replace them as they fail.

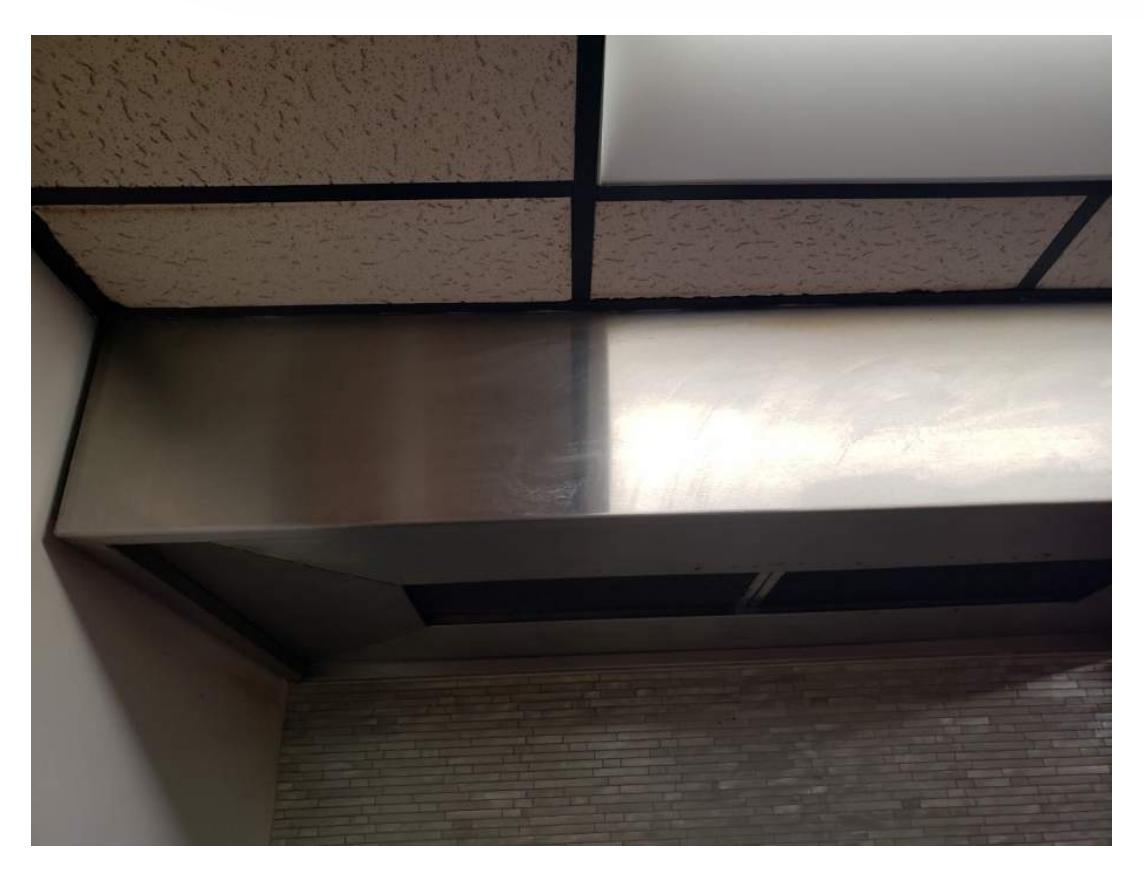
Image #10: Kitchen Exhaust Hood

The Kitchen includes a kitchen hood exhaust fan. This exhaust fan has been estimated to have been installed in 2019. The ASHRAE life expectancy for a fan of this type is 20 years. The hood and fan seem to be in acceptable condition for continued operation. Due to this, it is Paladin's recommendation that the kitchen exhaust fan remain. The exception to this is if the Kitchen is to expand and a higher capacity exhaust fan is required.

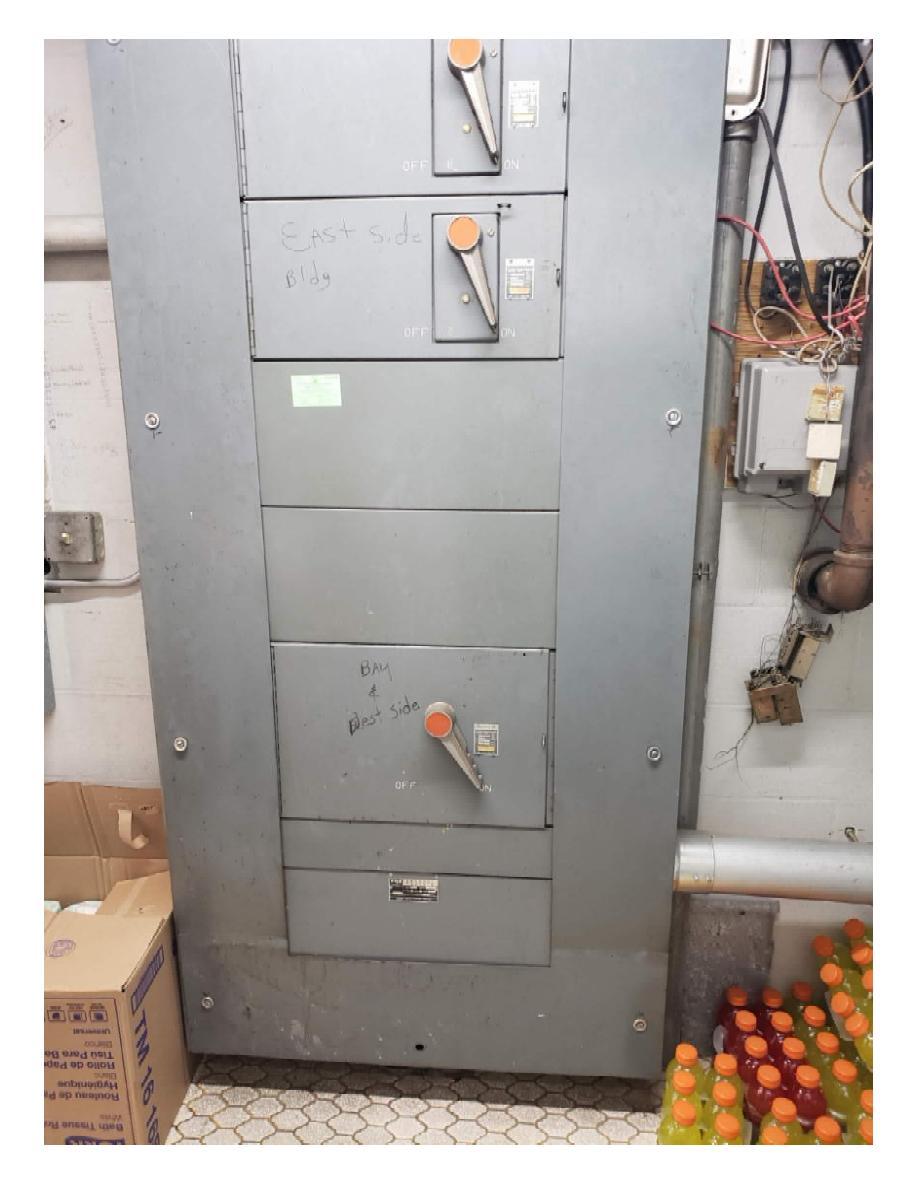
Image #11: Main Switchboard

The main switchboard serves the entire building. The typical operational lifespan of a main switchboard is expected to be thirty years. Since this switchboard is original to the building, that puts the current life of this equipment at almost twice what it was expected to achieve. Furthermore, the main switchboard is a Federal Pacific model which is outdated. These are often recommended for replacement regardless of their age. Due to this, Paladin recommends that the main switchboard be replaced.

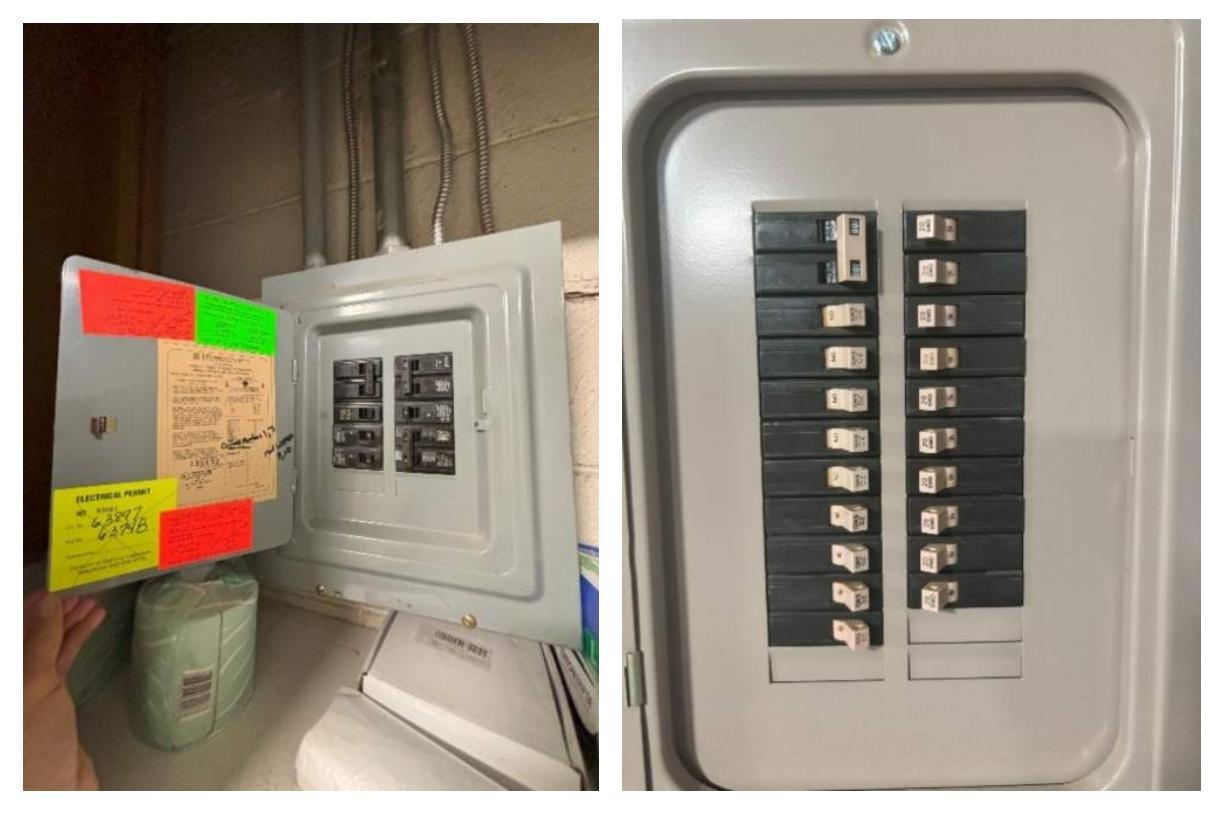
Images #12 & 13: ITE Panel (Left) and Cutler-Hammer Panel (Right)

The electrical distribution panels can be separated into two categories based upon manufacturer: Square D panels and non-Square D panels. There are two non-Square D panels. There is an ITE panel that serves the men's restroom and a Cutler-Hammer panel that serves the computer room. The ITE panel appears to be from 1977 and was not replaced with the restroom renovation project. The ITE panel is almost two decades past its expected operational life. The Cutler-Hammer panel has approximately 5 years of expected operational life remaining. Due to this, Paladin recommends that both panels be replaced. Replacing both panels with updated Square D panels would allow for increased versatility in the spaces, increased capacity, and a safer environment.

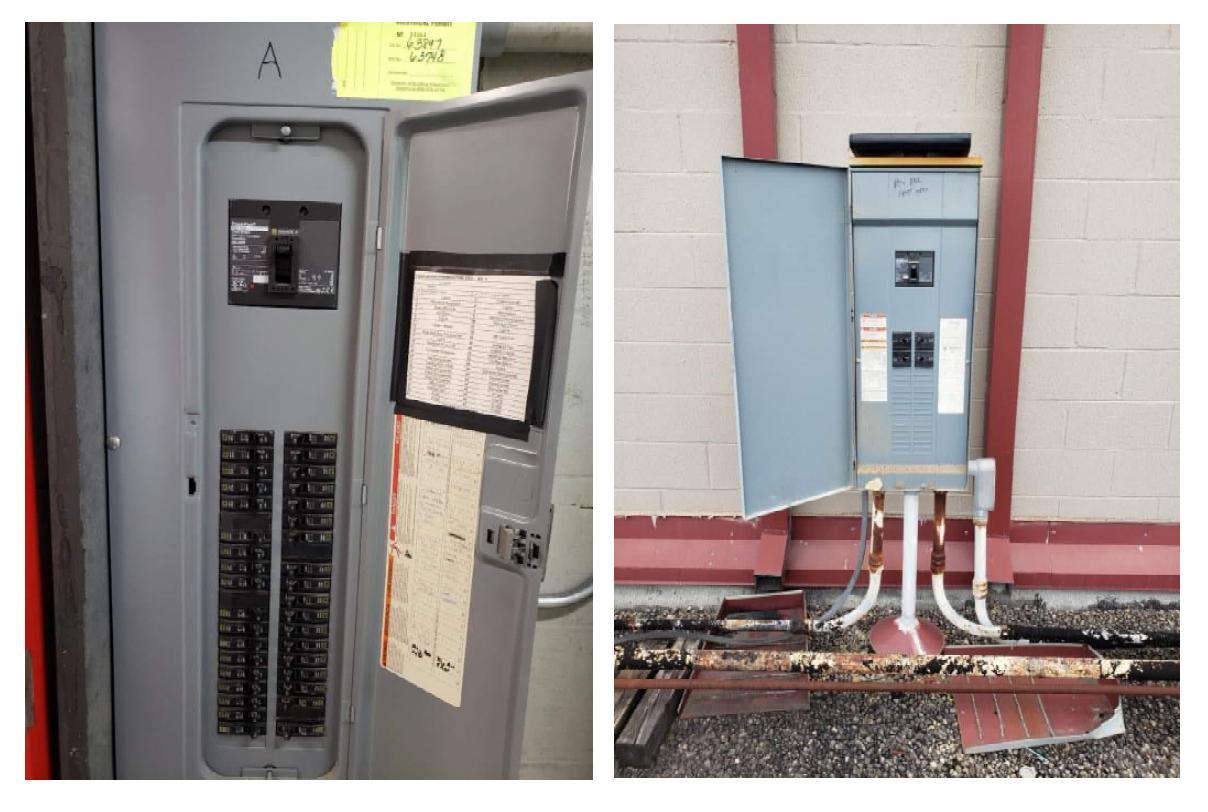
Images #14 & 15: Interior Square D Panel (Left) and Rooftop Panel (Right)

The eight Square D panels are generally in a similar good condition with approximately half of their thirty-year operational life expectancy remaining. The exceptions to this are the newly added panel to serve the 2023 office addition and the panels that are located on the roof to serve the RTUs. The new panel has its entire operational life remaining. The roof panels appear to be in acceptable condition; however, it cannot be determined when these panels were installed. The earliest estimate for the roof panels is 2001, while they could have been upgraded with the remaining panels in approximately 2008. The roof panels' enclosures have shown signs of aging but the equipment itself appears to be in acceptable condition. Due to this, Paladin recommends that all the Square D electrical distribution panels are to remain.

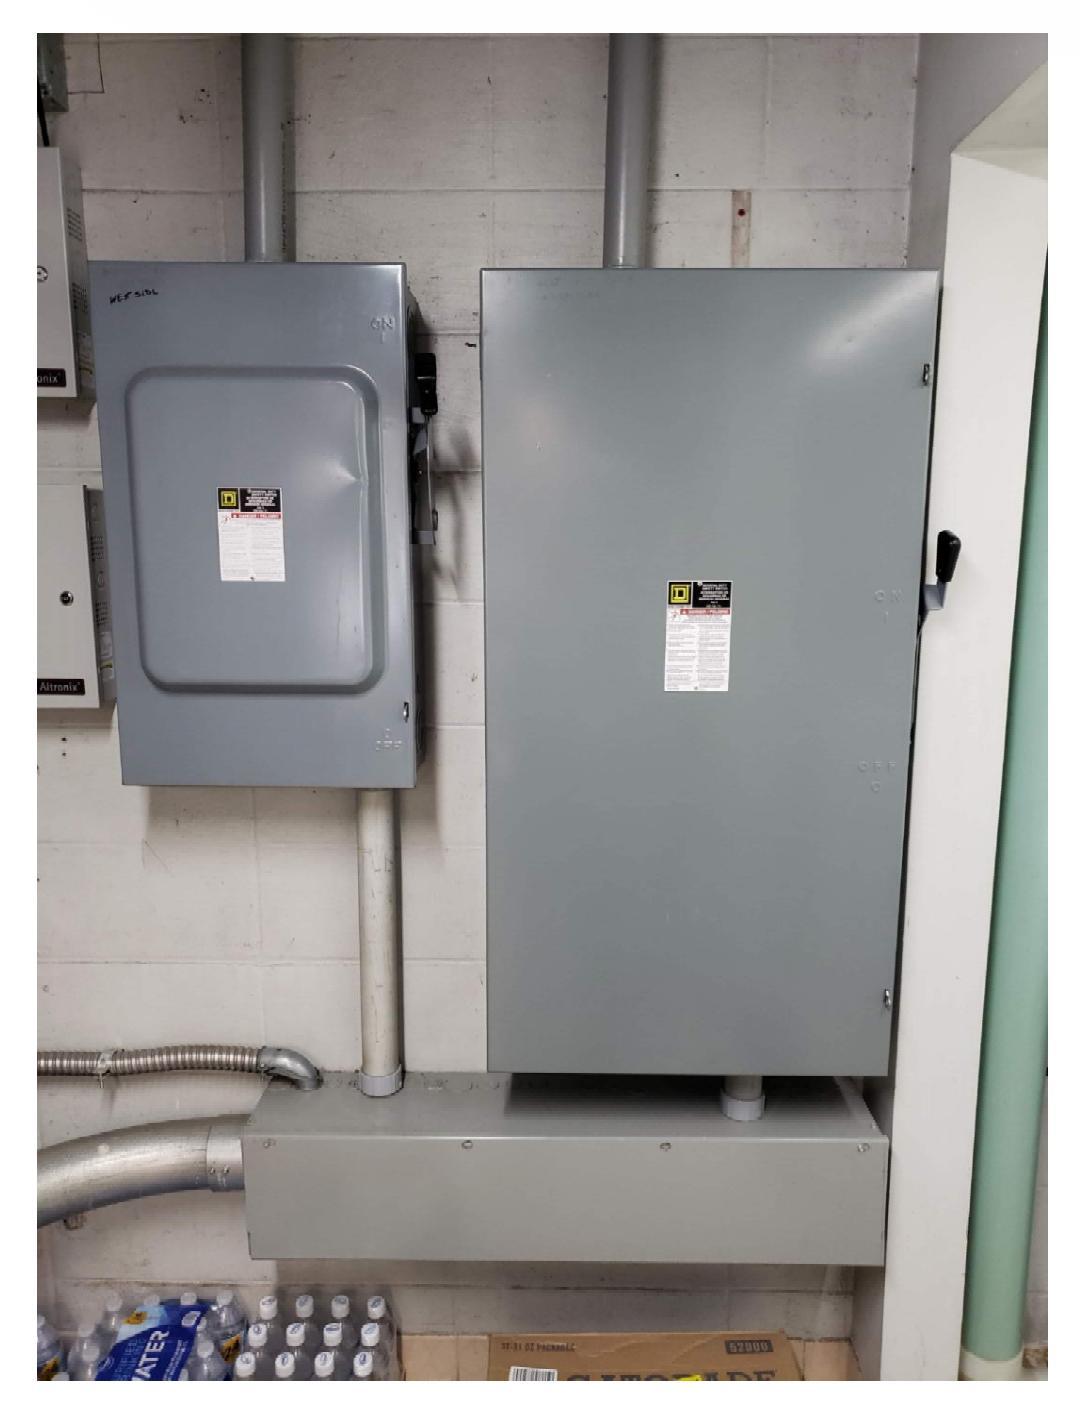
Image #16: Disconnect Switches for Roof Panels

The two large disconnect switches each serve a roof distribution panel. These disconnect switches were both made by Square D and approximately installed in 2008. There appears to be no significant signs of distress or failures. Due to this, Paladin recommends that the large disconnect switches serving the roof are to remain.

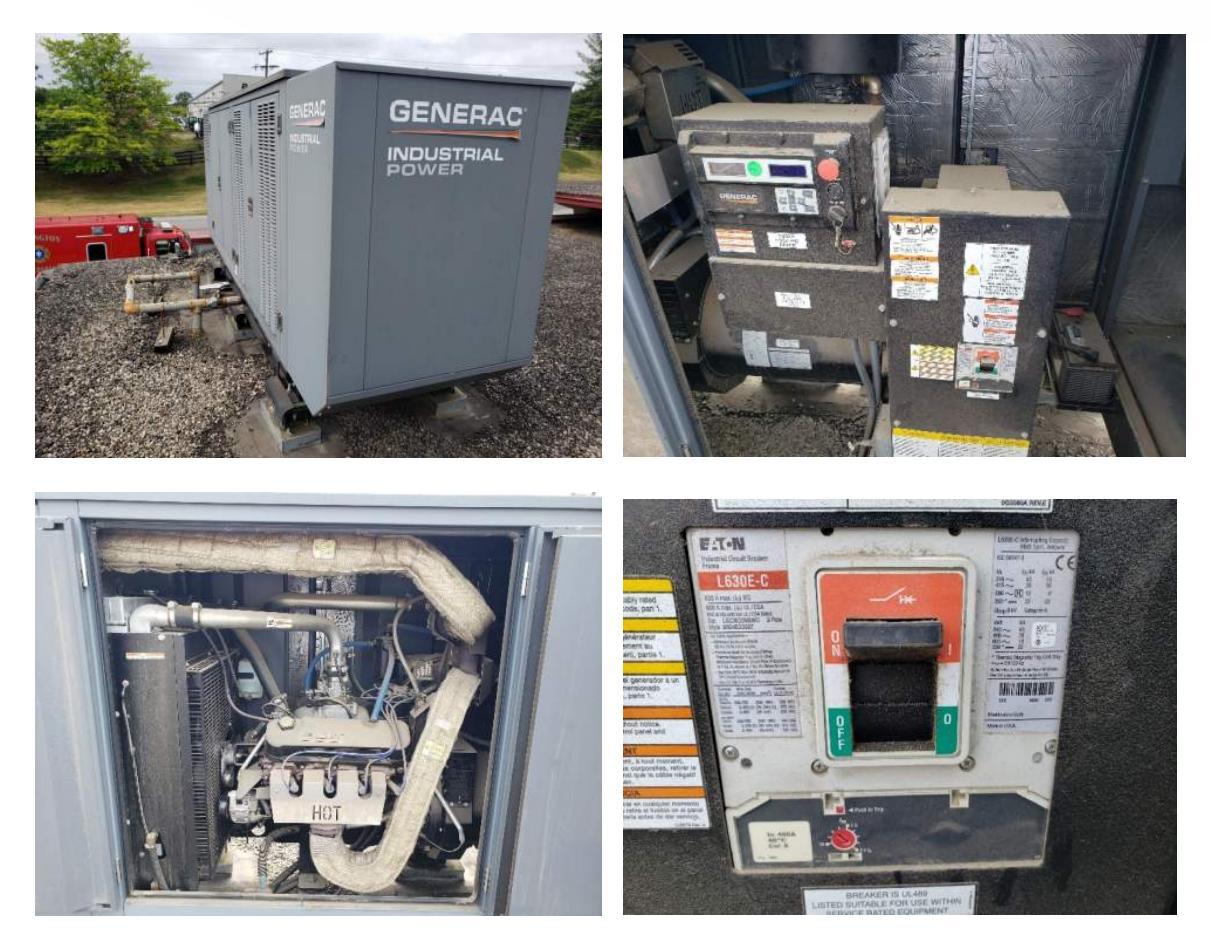
Images #17, 18, 19, & 20: Generator Exterior and Interior Components

The backup generator serving the building was installed in 2015. It has been reported that it serves only the west half of the building. The expected life span of the generator is thirty years. Reports show that the generator is up to date on regularly scheduled maintenance. Due to this, Paladin recommends that the generator remains as is.

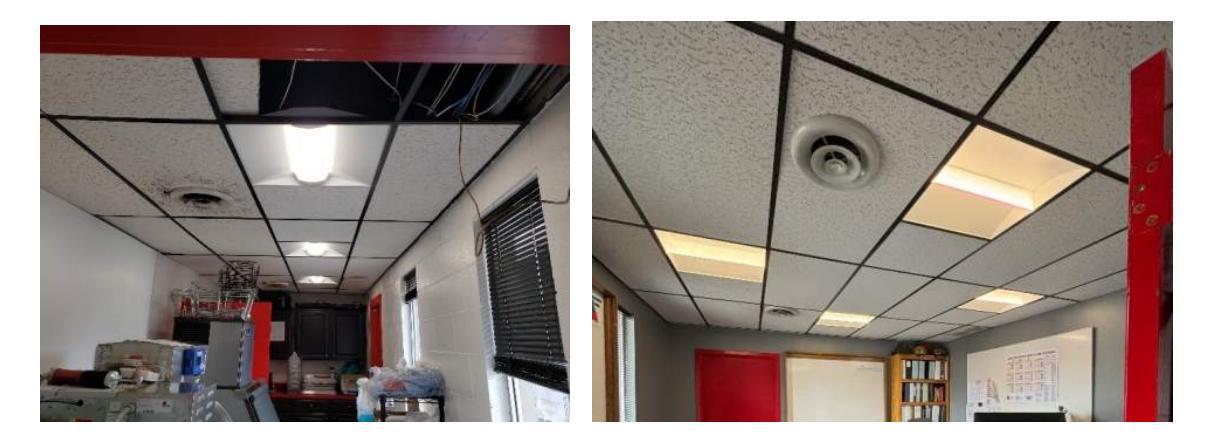
Images #21 & 22: LED Fixture from 2010 Replacement (Left) and LED Fixture from 2017 Replacement (Right)

The lighting in the building has been replaced at various points, causing lighting color and fixtures to be nonuniform throughout the facility. The majority of the lighting fixtures were reported to be replaced with LED fixtures in approximately 2010. A separate replacement project was implemented for the lighting fixtures in approximately 2017 for a small number of fixtures in the office spaces. The 2017 replacement project featured another upgrade of lighting fixtures to LED fixtures. Finally, the 2023 addition included its own new LED fixtures as well. Paladin recommends the LED fixtures to remain. The exception to this would be if uniform lighting fixtures are desired. This conformity would require a replacement of lighting fixtures.
