# Lexington-Fayette Urban County Government

The Lexington-Fayette Urban County Government hereby requests proposals for **RFP #16-2025 Site Development of the Fire Training Academy Campus Phase I** to be provided in accordance with terms, conditions and specifications established herein.

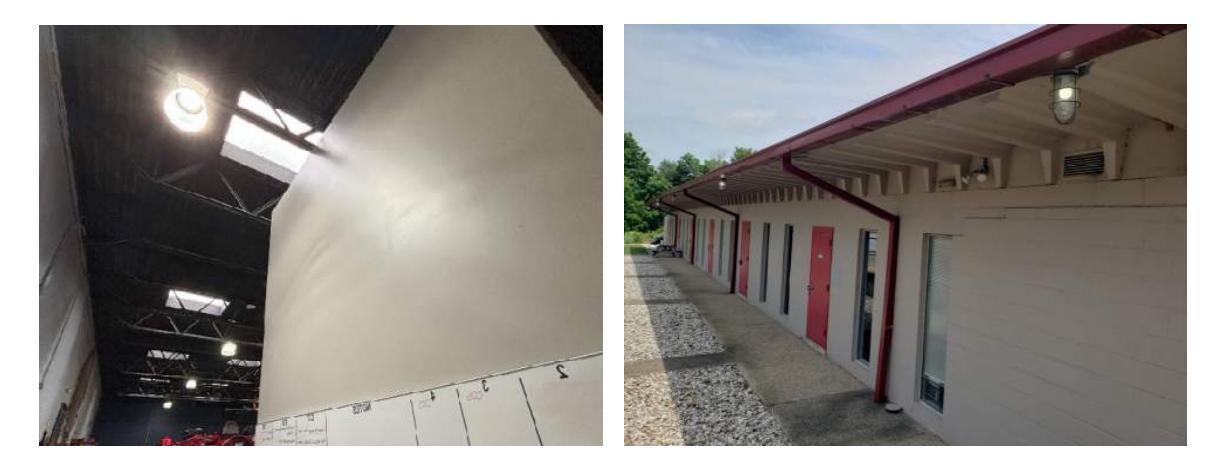
Images #23 & 24: Metal Halide Fixtures (Left) and Exterior Incandescent Lights (Right)

The lighting fixtures for the facility are not all LED fixtures. There are metal halide lights in the Bay, incandescent can lights in the Lobby, Computer Room, and Chief's Restroom, and incandescent exterior light fixtures. To increase energy efficiency, Paladin recommends replacing all lighting fixtures that are not LED to be updated to LED fixtures.

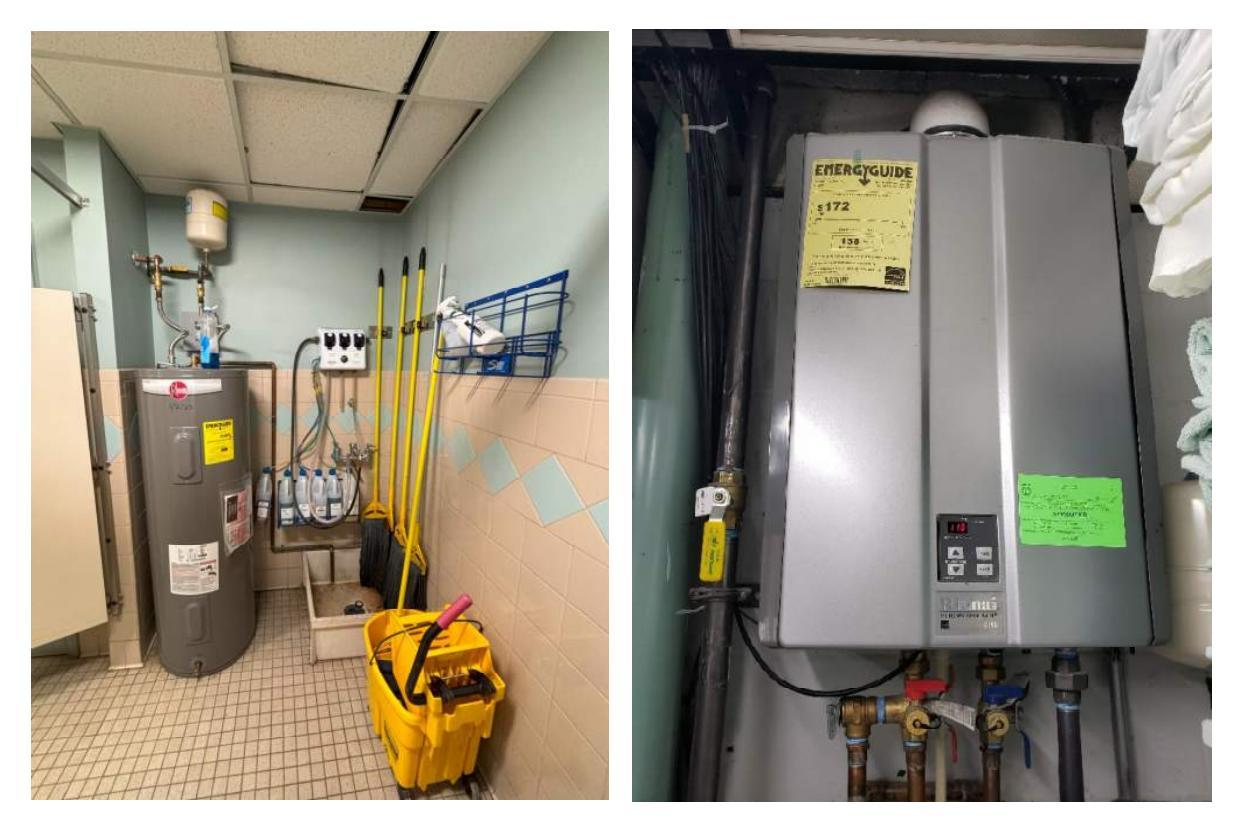
Images #25 & 26: Tanked Electric Water Heater (Left) and Instantaneous Gas Water Heater (Right)

The building's domestic hot water is generated by two sources: an electric tank-style water heater and an instantaneous gas water heater. Each of these water heaters serves a different side of the building. The electric water heater serves the west side of the building. This includes the men's restroom and the chiefs' office restroom. The gas water heater serves the east side of the building. This includes the women's restroom, the laundry room, and the kitchen. The electric water heater was replaced in 2023. The gas water heater was installed in 2015. Both pieces of equipment are in good condition, and both also have over ten years of operable life remaining. Due to this, it is Paladin's recommendation that these units remain.
