**LEXINGTON-FAYETTE URBAN COUNTY GOVERNMENT
CONTRACT CHANGE ORDER**
Page 1 of 2

Project: Black & Williams Center Roof Replacement & Repairs

Change Order No. 1

JUSTIFICATION FOR CHANGE

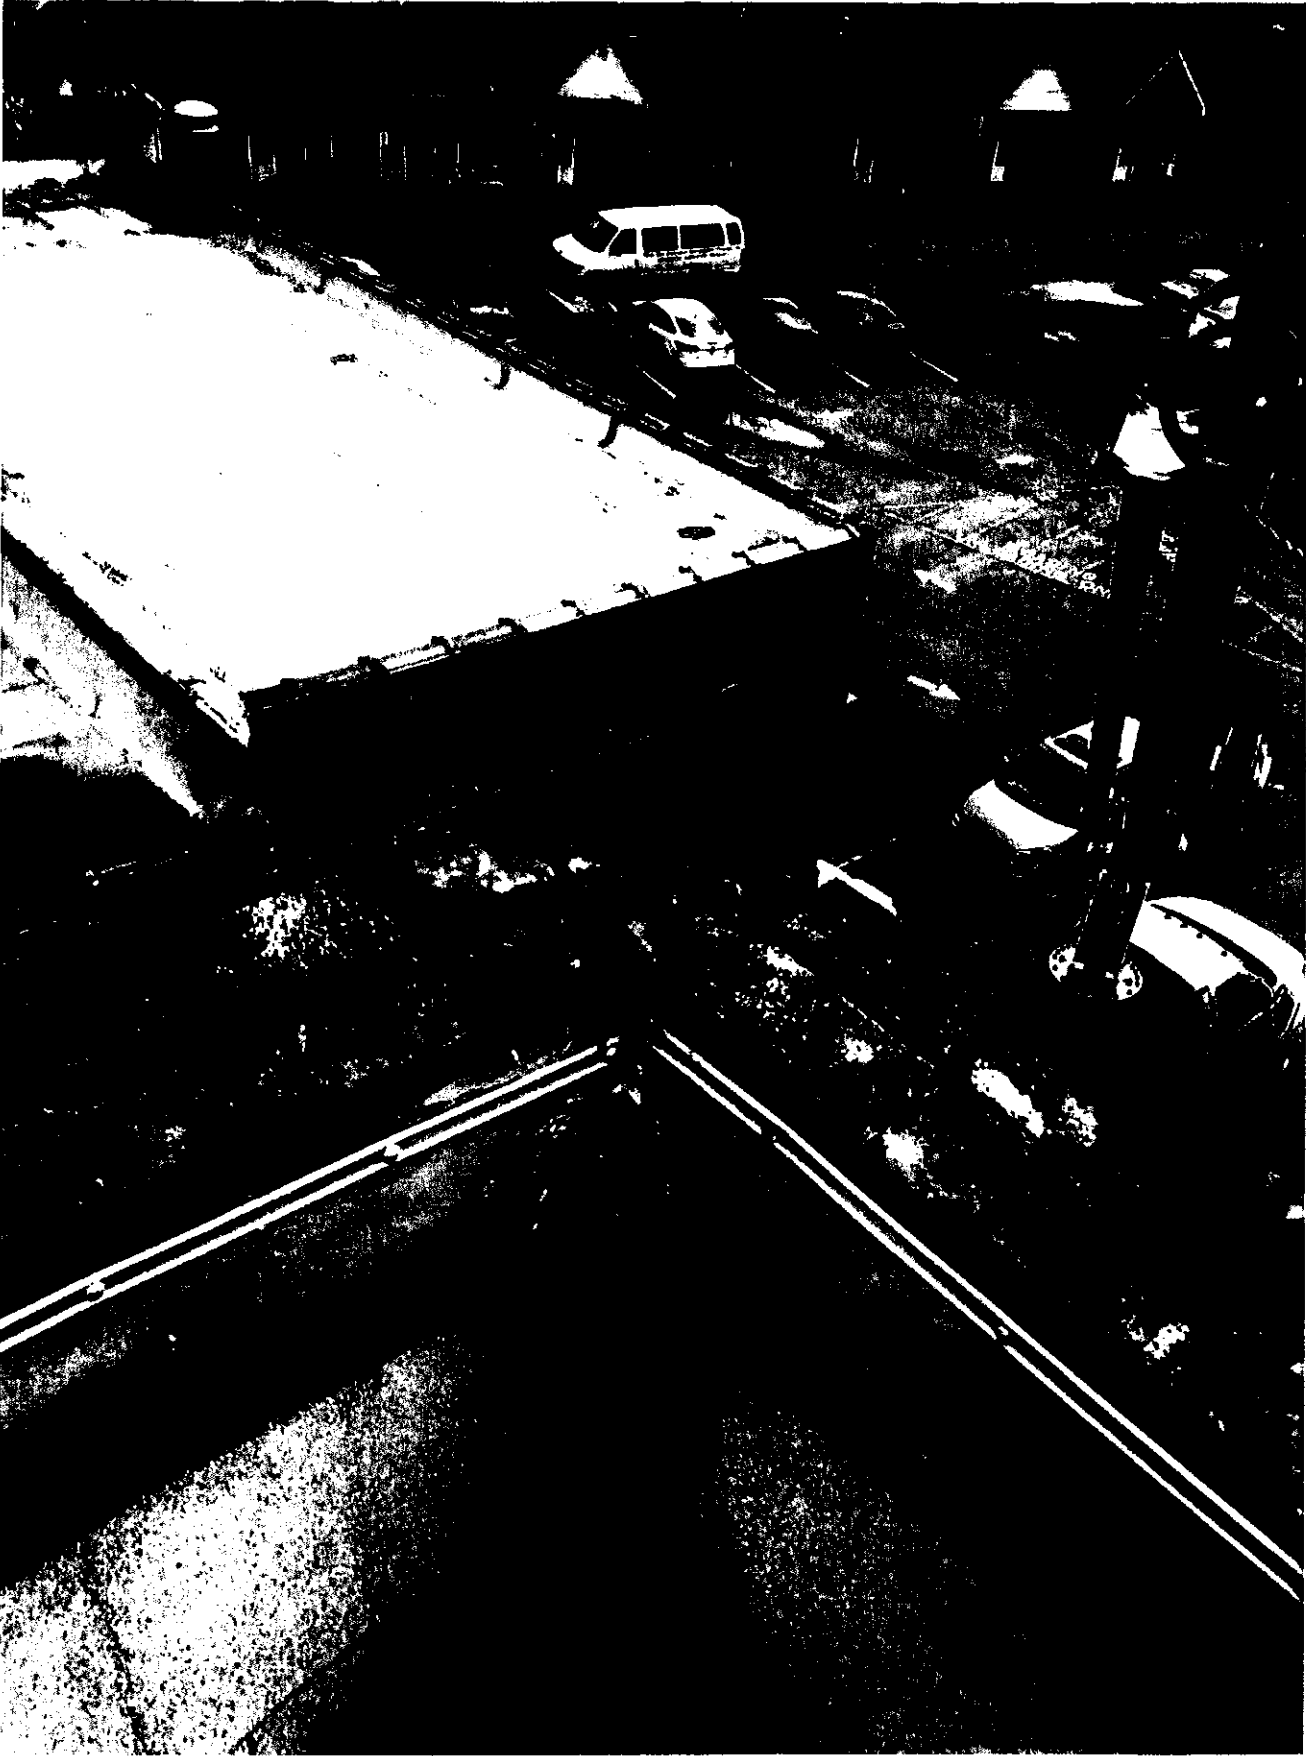
Attached are two pictures of brick condition on a section of parapet walls on Roof Area 1. There is little to no mortar around many of the bricks in the pictures.

I reviewed the conditions shown in the photograph today during the intermediate roof inspection. I recommend approval of the proposal to stabilize the top (3) courses of the 2 wythe brick wall as proposed for an increase cost in the amount of \$3,340.00
This is CRITICAL PATH WORK – and requires attention as soon as possible to prevent unnecessary delays in the work.

Per the email regarding the deteriorated parapet wall brick condition, Gilpin Masonry has provided the following change order to make repairs...

- To an estimated 45' of wall, we will remove and reset two wythes of brick approximately three courses deep. The brick will be removed from the wall, cleaned of all old mortar and reset with matching mortar as previously submitted. Change Order ADD price: \$3,340.00
